SUBJECT: ENG – Trip Report
Quileute Indian Nation
Thunder Road Site 1 – Culvert
Clallam County, WA

PURPOSE

On October 27, 2015, we visited the Thunder Road Site 1 to explore geotechnical foundation conditions for removal of an existing culvert and replacement with a larger culvert. The new culvert will improve conditions for the passage of aquatic organisms (Figure 1). The site is located on an unnamed tributary to the Quillayute River along Thunder Road.

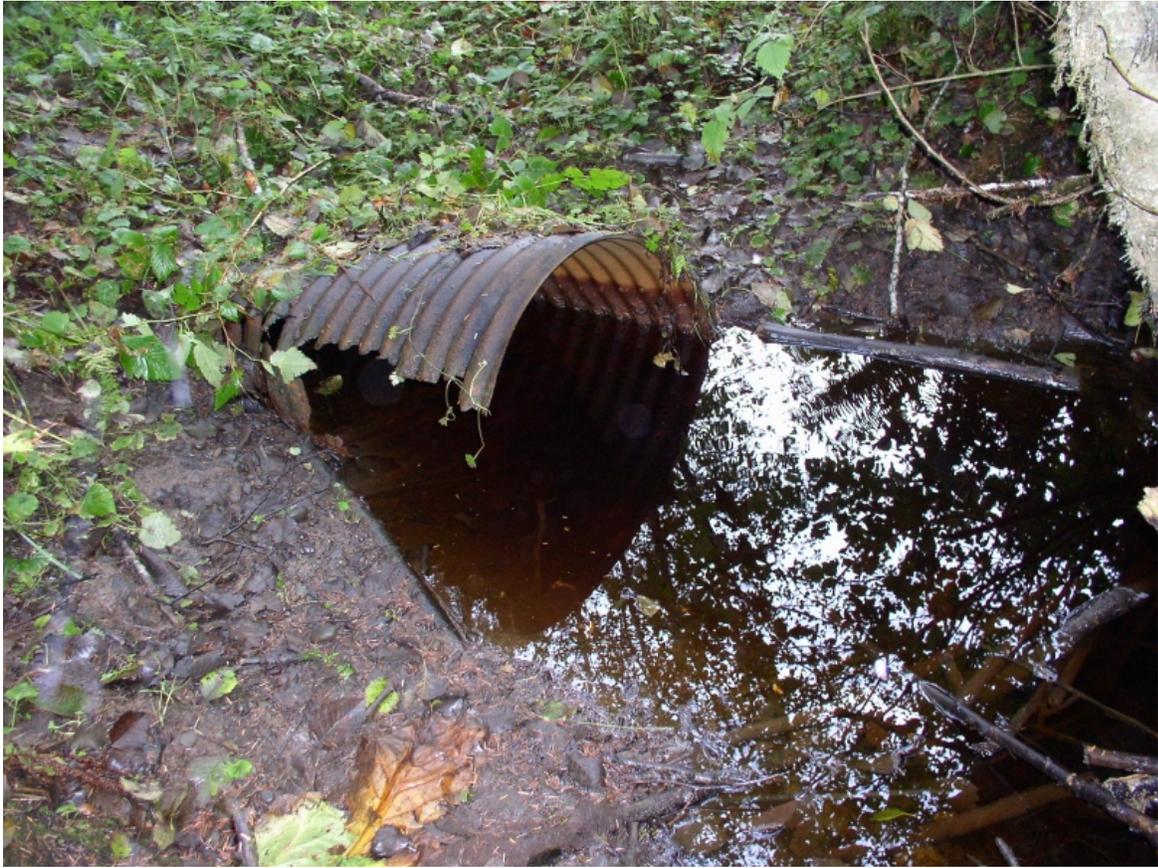
Figure 1. Image looking upstream at existing culvert crossing.

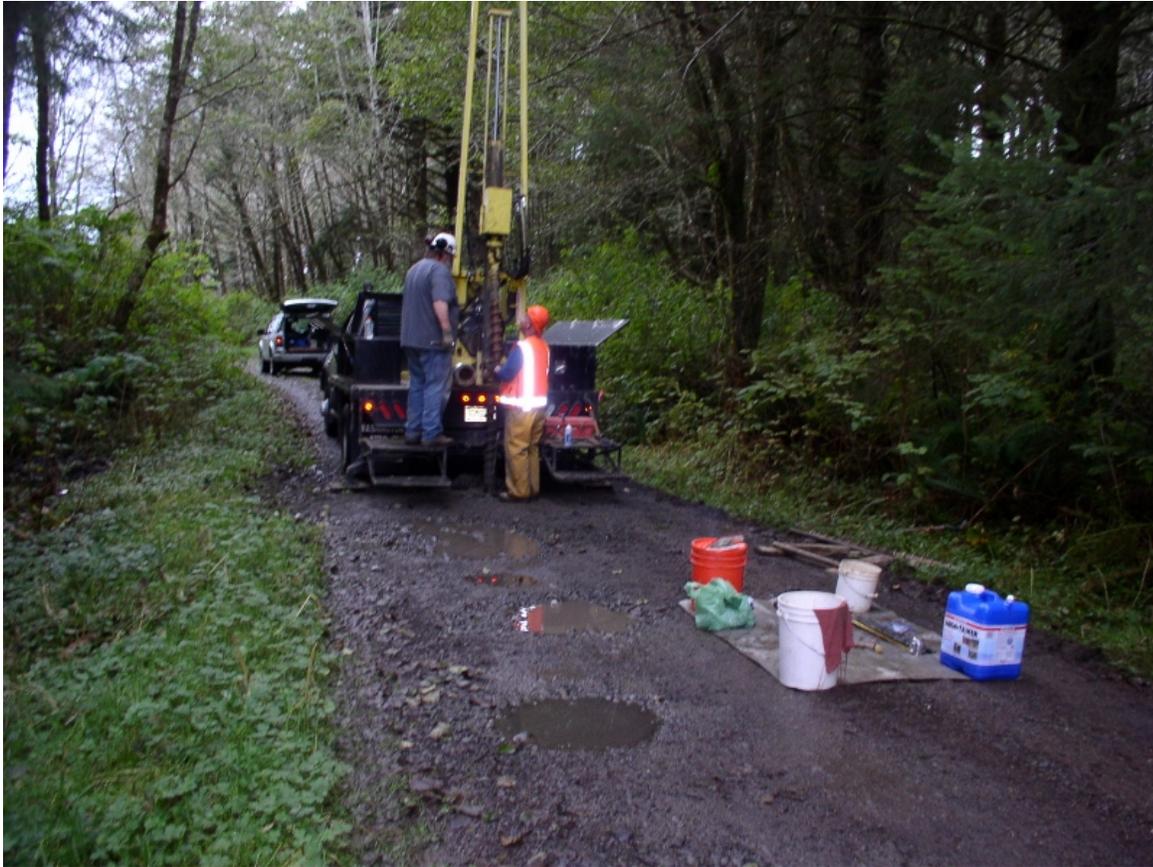
We drilled one exploratory hole through the centerline of Thunder Road: DH1, 20 feet east of the existing culvert. The general location of the drill hole is shown in Figure 2. Figure 3 shows the drill rig set up at DH1.

Figure 3. Drill rig set up at Site 1, DH1. Photo looking west.

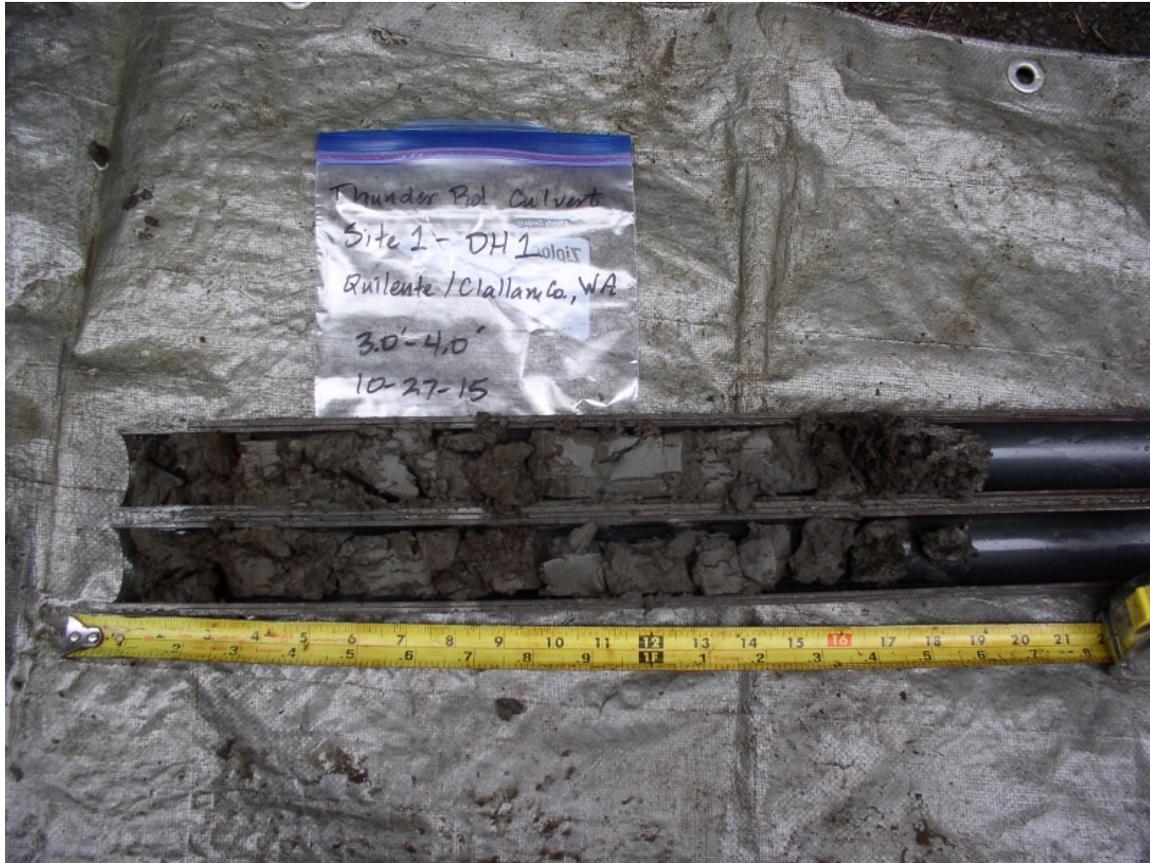
<u>SPT</u>	<u>Number of Blows</u>
2.5 to 3.0 feet	set sampler
3.0 to 3.5 feet	2
<u>3.5 to 4.0 feet</u>	<u>1</u>
Blows per foot, N =	3

3.0 to 4.0 feet: OH, high-plastic organic silt with woody fragments, saturated, gray-brown, soft consistency (Figure 4). Sample collected for laboratory classification.

Figure 4. View of sample recovered from a depth of 3.0 to 4.0 feet.

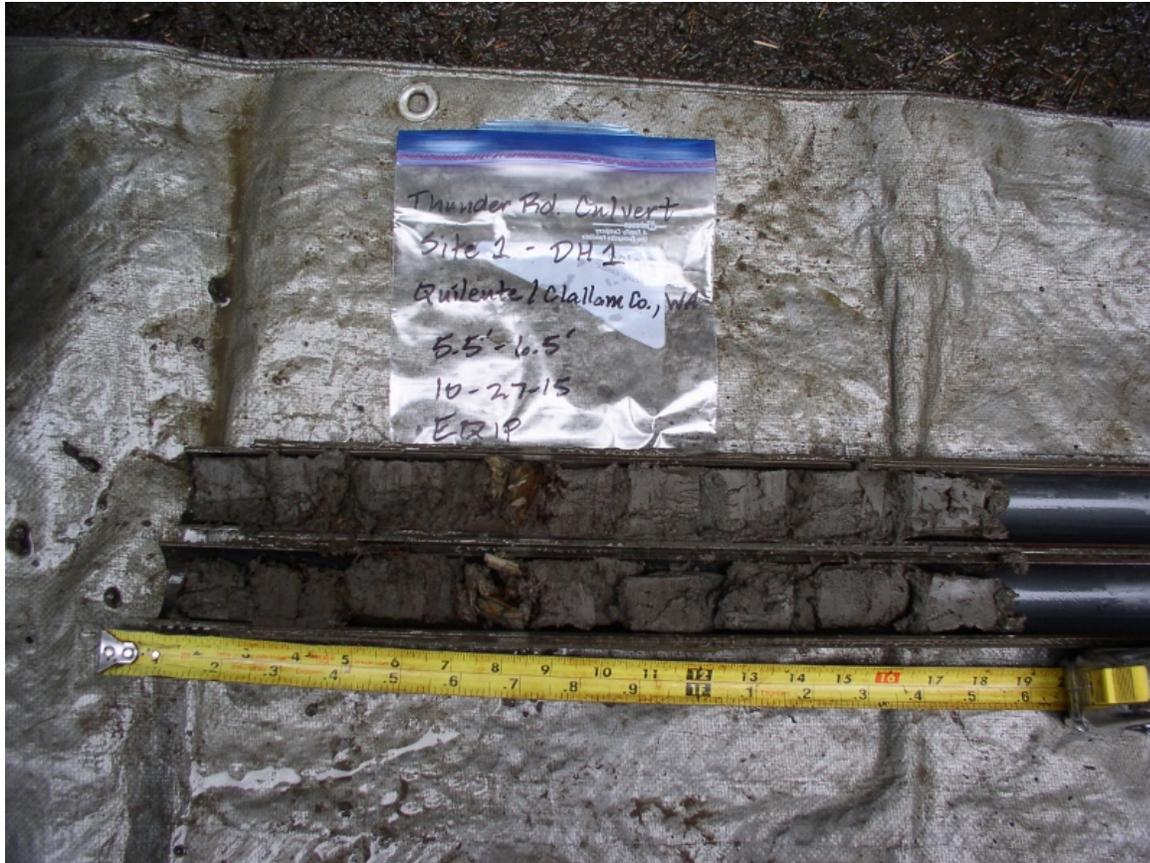
<u>SPT</u>	<u>Number of Blows</u>
5.0 to 5.5 feet	sank
5.5 to 6.0 feet	0
6.0 to 6.5 feet	1
Blows per foot, N =	1

5.5 to 6.5 feet: OH, high-plastic organic silt with woody fragments, saturated, gray-brown, very soft consistency, sampler sank the first six inches under the weight of the hammer (Figure 5). Sample collected for laboratory classification.

Figure 5. View of sample recovered from a depth of 5.5 to 6.5 feet.

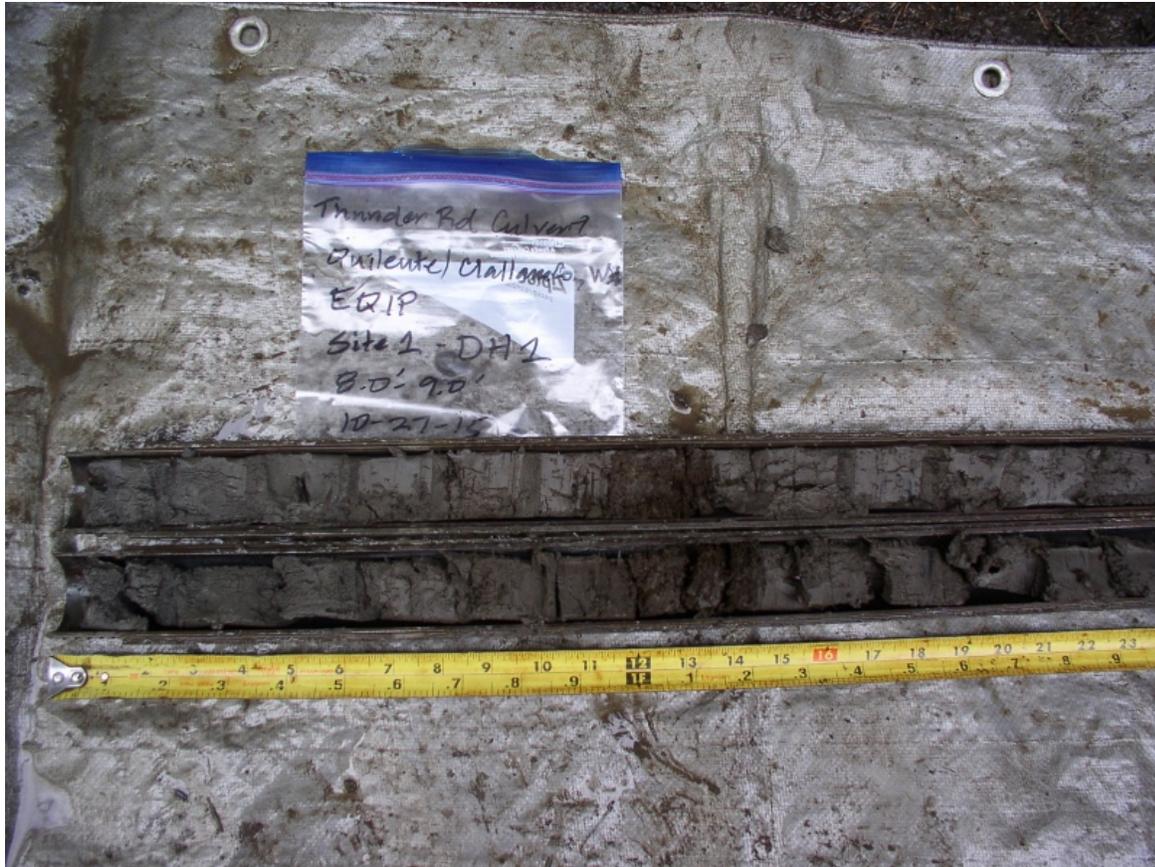
<u>SPT</u>	<u>Number of Blows</u>
7.5 to 8.0 feet	sank
8.0 to 8.5 feet	1
<u>8.5 to 9.0 feet</u>	<u>1</u>
Blows per foot, N =	2

8.0 to 9.0 feet: OH, high-plastic organic silt with woody fragments and charcoal, saturated, gray-brown, soft consistency, sampler sank the first six inches under the weight of the hammer (Figure 6). Sample collected for laboratory classification.

Figure 6. View of sample recovered from a depth of 8.0 to 9.0 feet.

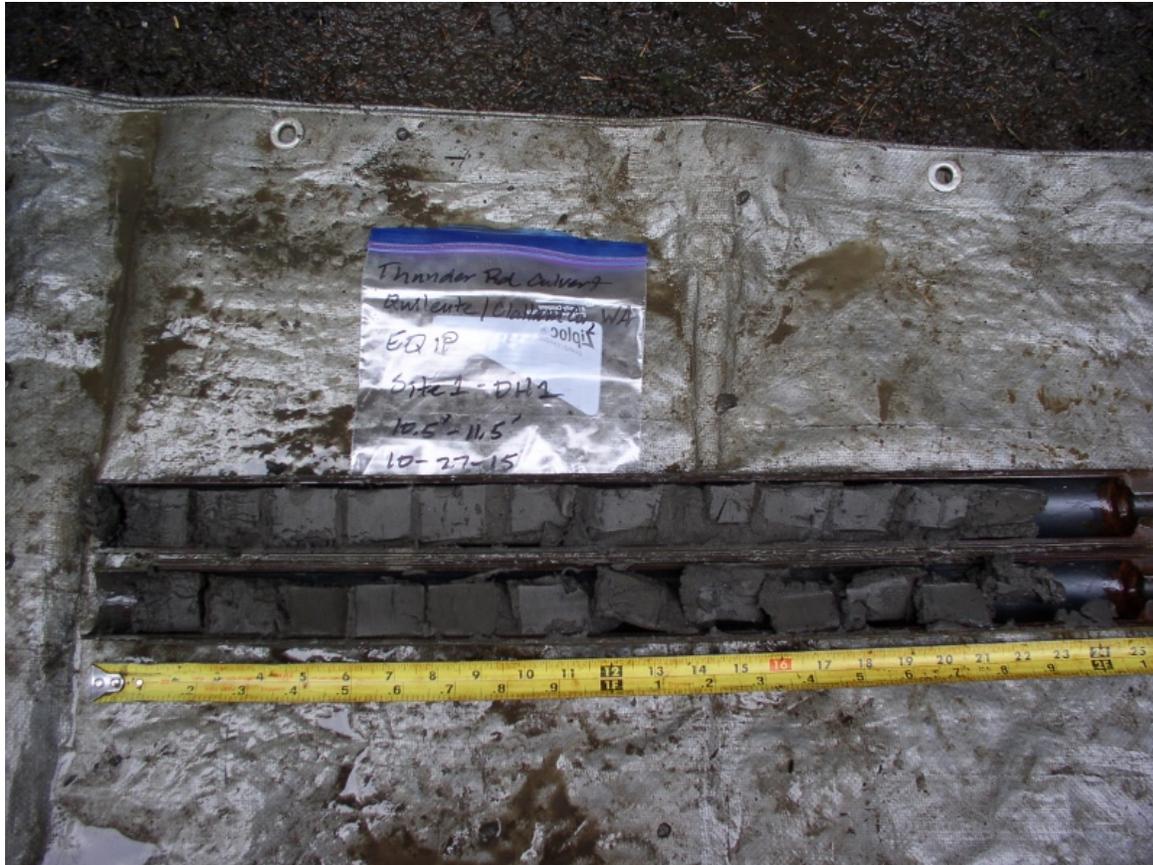
<u>SPT</u>	<u>Number of Blows</u>
10.0 to 10.5 feet	sank
10.5 to 11.0 feet	0
11.0 to 11.5 feet	0
Blows per foot, N =	0

10.5 to 11.5 feet: ML/OH, silt to high-plastic organic silt, saturated, reduced, blue-gray/brown, very soft consistency, sampler sank under the weight of the hammer (Figure 7). Sample collected for laboratory classification.

Figure 7. View of sample recovered from a depth of 10.5 to 11.5 feet.

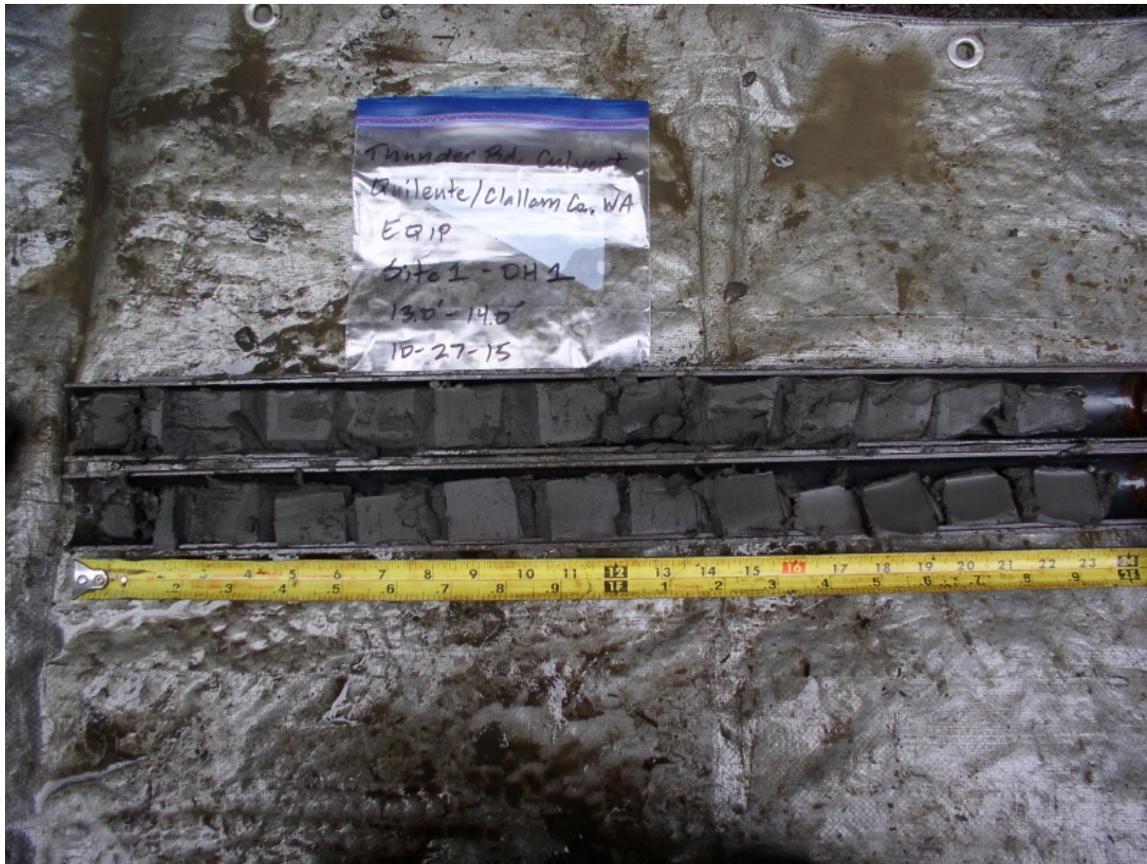
<u>SPT</u>	<u>Number of Blows</u>
12.5 to 13.0 feet	sank
13.0 to 13.5 feet	0
13.5 to 14.0 feet	0
Blows per foot, N =	0

13.0 to 14.0 feet: ML/OH, silt to high-plastic organic silt, saturated, reduced, blue-gray, very soft consistency, sampler sank under the weight of the hammer (Figure 8). Sample collected for laboratory classification.

Figure 8. View of sample recovered from a depth of 13.0 to 14.0 feet.

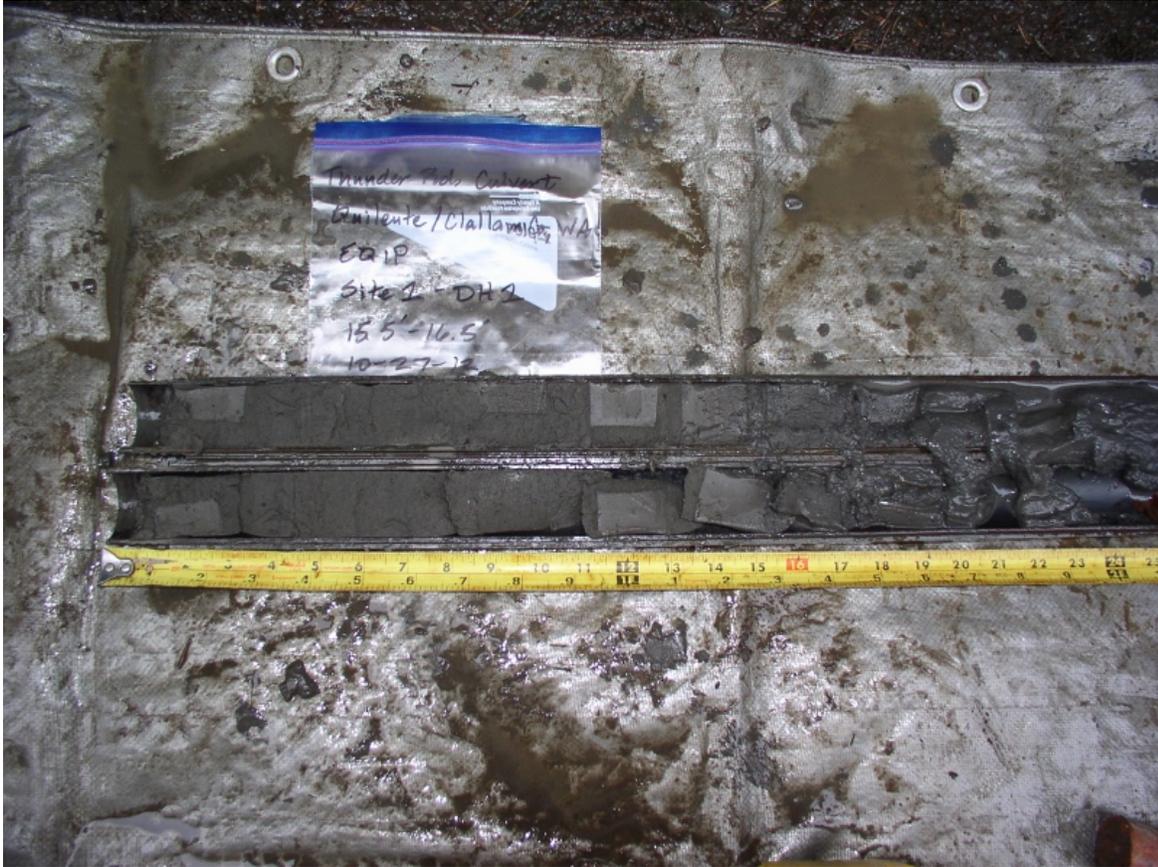
<u>SPT</u>	<u>Number of Blows</u>
15.0 to 15.5 feet	sank
15.5 to 16.0 feet	0
<u>16.0 to 16.5 feet</u>	<u>0</u>
Blows per foot, N =	0

15.5 to 16.5 feet: ML/OH, silt to high-plastic organic silt, saturated, free water, reduced, blue-gray, very soft consistency, sampler sank under the weight of the hammer (Figure 9). Sample collected for laboratory classification.

Figure 9. View of sample recovered from a depth of 15.5 to 16.5 feet.
