SUBJECT: ENG – Trip Report  
Quileute Indian Nation  
Thunder Road Site 4 – Bridge  
Clallam County, WA

## **PURPOSE**

On March 22, 2016, we visited Thunder Road Site 4 to explore geotechnical foundation conditions for removal of an existing culvert and replacement with a bridge. The new bridge will improve conditions for the passage of aquatic organisms (Figure 1). The site is located on an unnamed tributary to the Quillayute River along Thunder Road.

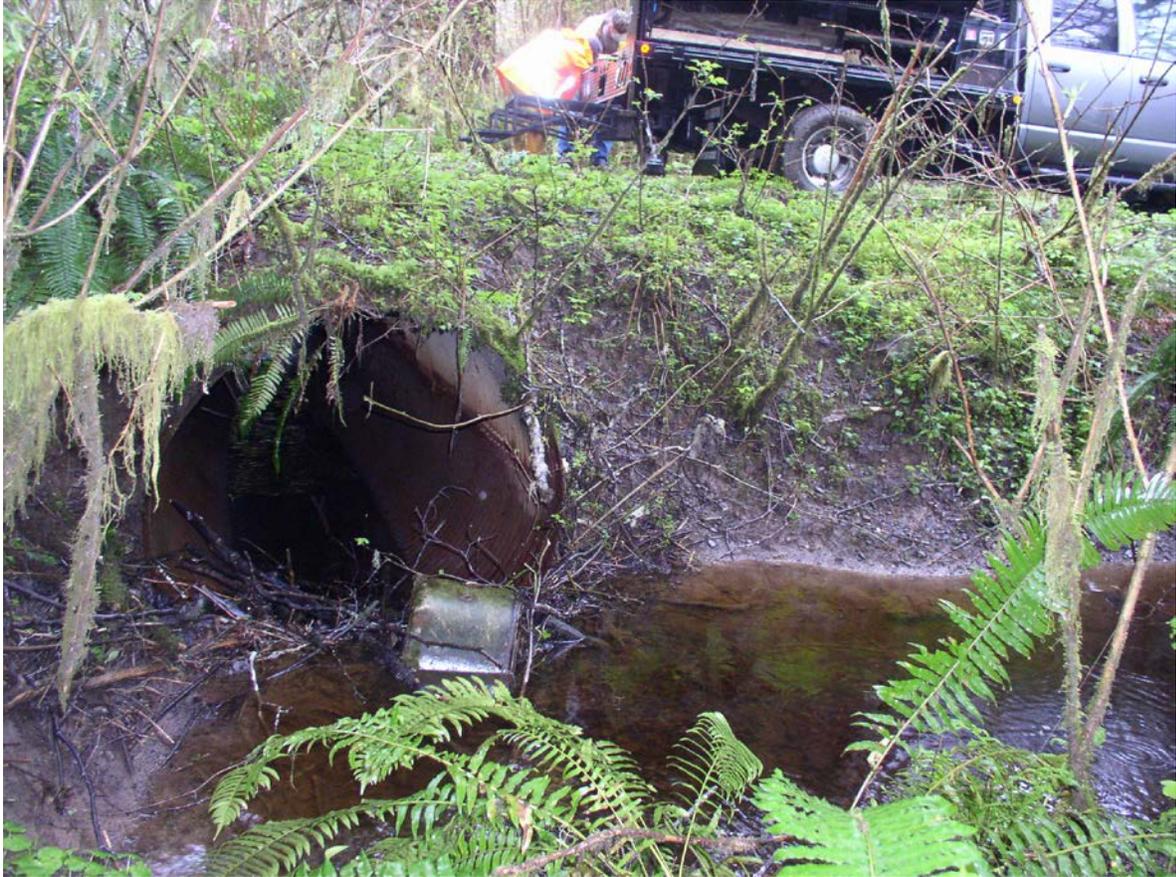
Figure 1. Image looking downstream at inlet of existing culvert at Site 4 along Thunder Road.

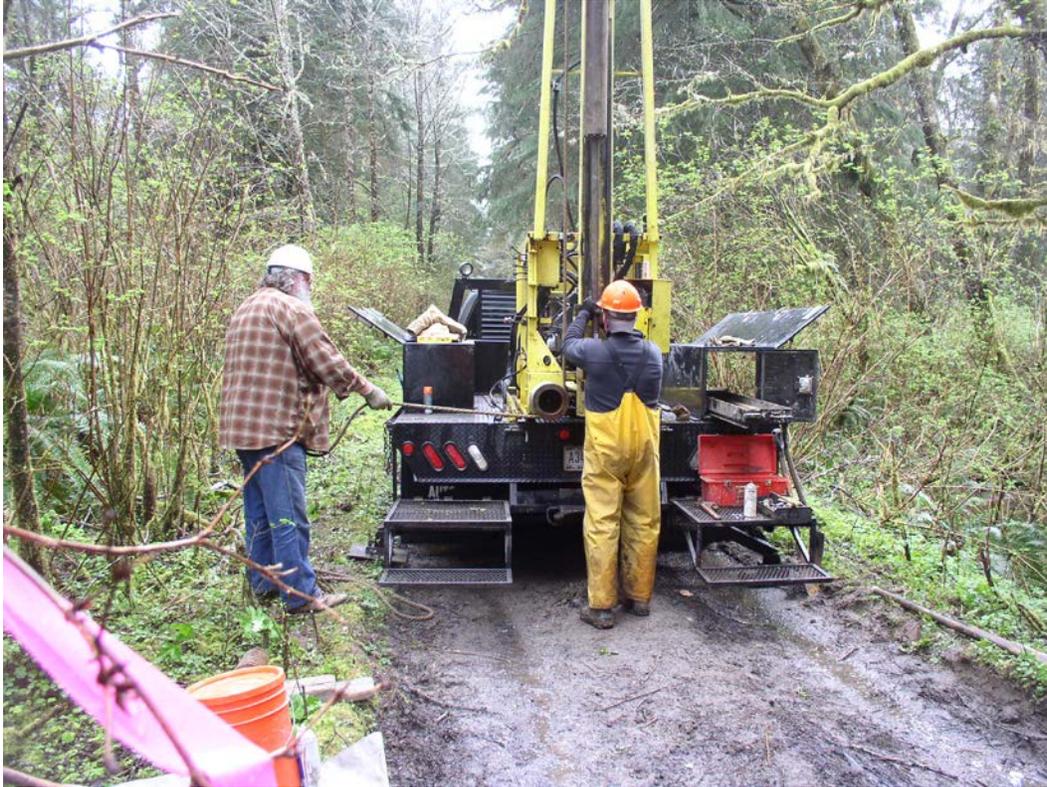
Figure 3. Drill rig set up at Site 4, DH1. Photo looking east.

We drilled one exploratory hole through the centerline of Thunder Road about 10 feet east of the centerline of the existing culvert. The general location of the drill hole and Site 4 is shown in Figure 2. Figure 3 shows the drill rig set up at DH1. We did not drill the west abutment due to rainy conditions that posed a safety hazard.

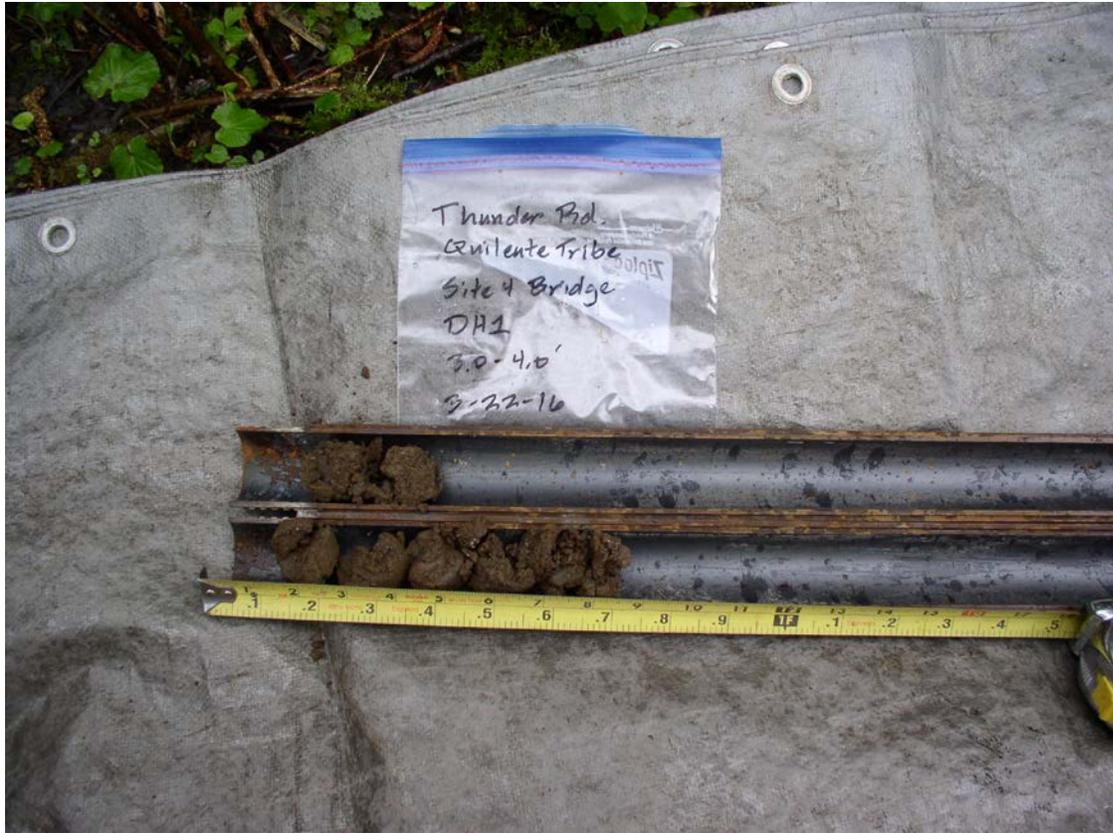
<u>SPT</u>	<u>Number of Blows</u>
2.5 to 3.0 feet	set sampler
3.0 to 3.5 feet	2
<u>3.5 to 4.0 feet</u>	<u>0</u>
Blows per foot, N =	2

3.0 to 4.0 feet: GM, silty gravel, road fill, oxidized, red-brown, saturated, very loose relative density (Figure 4). Sample collected for laboratory classification.

Figure 4. View of sample recovered from a depth of 3.0 to 4.0 feet.

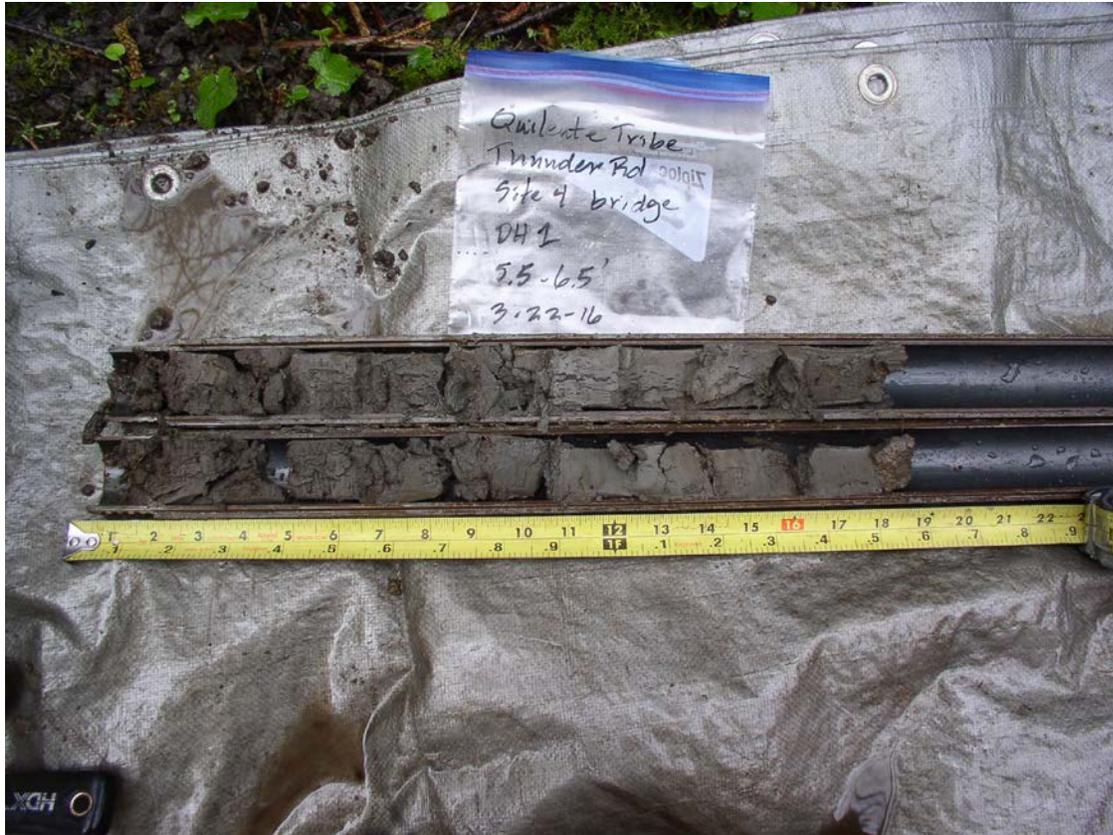
<u>SPT</u>	<u>Number of Blows</u>
5.0 to 5.5 feet	set sampler
5.5 to 6.0 feet	2
6.0 to 6.5 feet	1
Blows per foot, N =	3

5.5 to 6.5 feet: ML/OH, silt with organics, reduced, blue-gray, saturated, soft consistency (Figure 5). Sample collected for laboratory classification.

Figure 5. View of sample recovered from a depth of 5.5 to 6.5 feet.

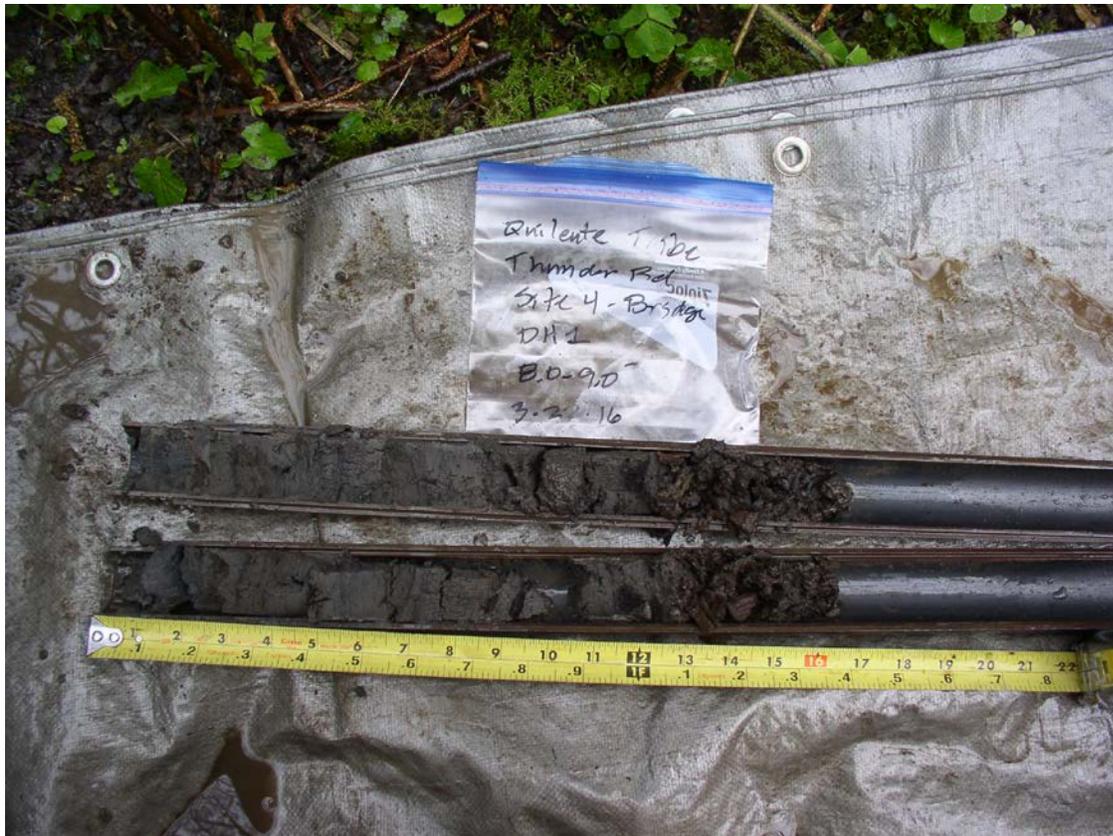
SPT	Number of Blows
7.5 to 8.0 feet	set sampler
8.0 to 8.5 feet	1
8.5 to 9.0 feet	2
Blows per foot, N =	3

8.0 to 9.0 feet: ML, silt with wood fragments, organics and thin silty sand (SM) layers, reduced, blue-gray, saturated, soft consistency (Figure 6). Sample collected for laboratory classification.

Figure 6. View of sample recovered from a depth of 8.0 to 9.0 feet.

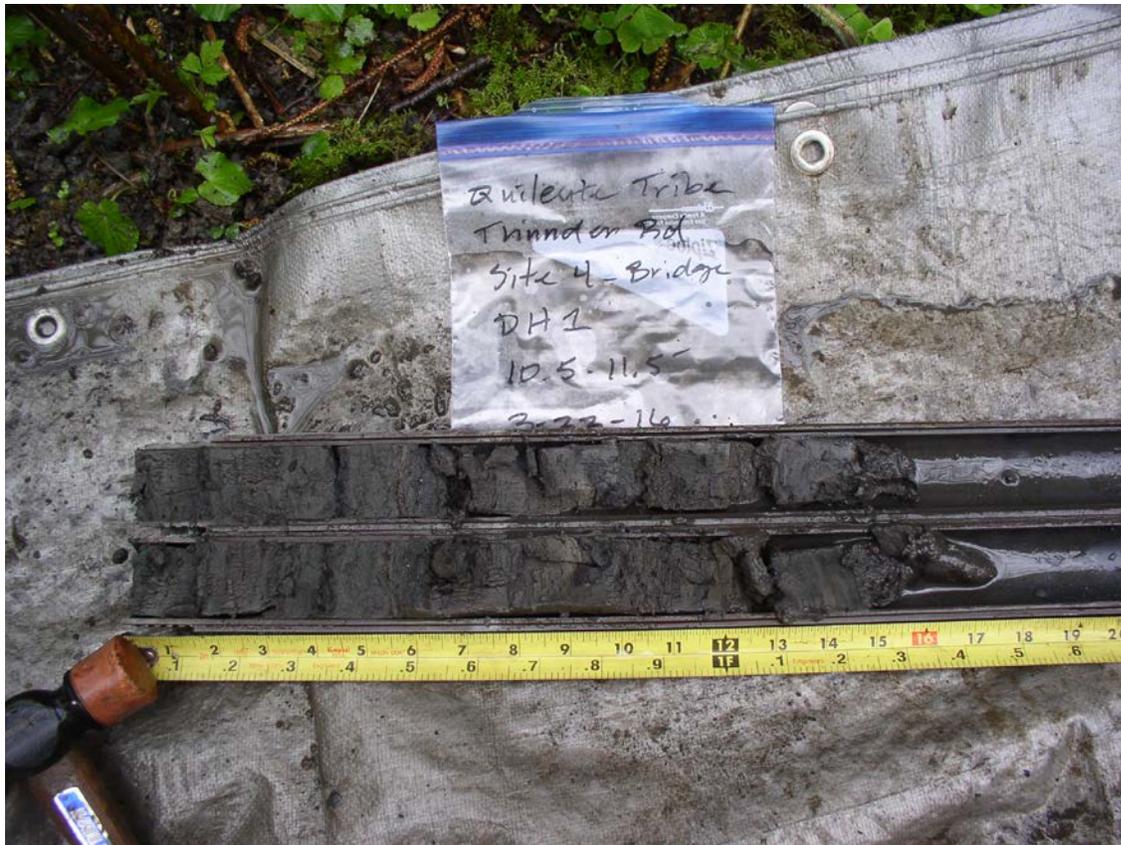
<u>SPT</u>	<u>Number of Blows</u>
10.0 to 10.5 feet	set sampler
10.5 to 11.0 feet	3
11.0 to 11.5 feet	2
Blows per foot, N =	5

10.5 to 11.5 feet: ML/SM, silt to silty sand with organics and wood fragments, reduced, blue-gray, saturated, medium consistency/loose relative density (Figure 7). Sample collected for laboratory classification.

Figure 7. View of sample recovered from a depth of 10.5 to 11.5 feet.

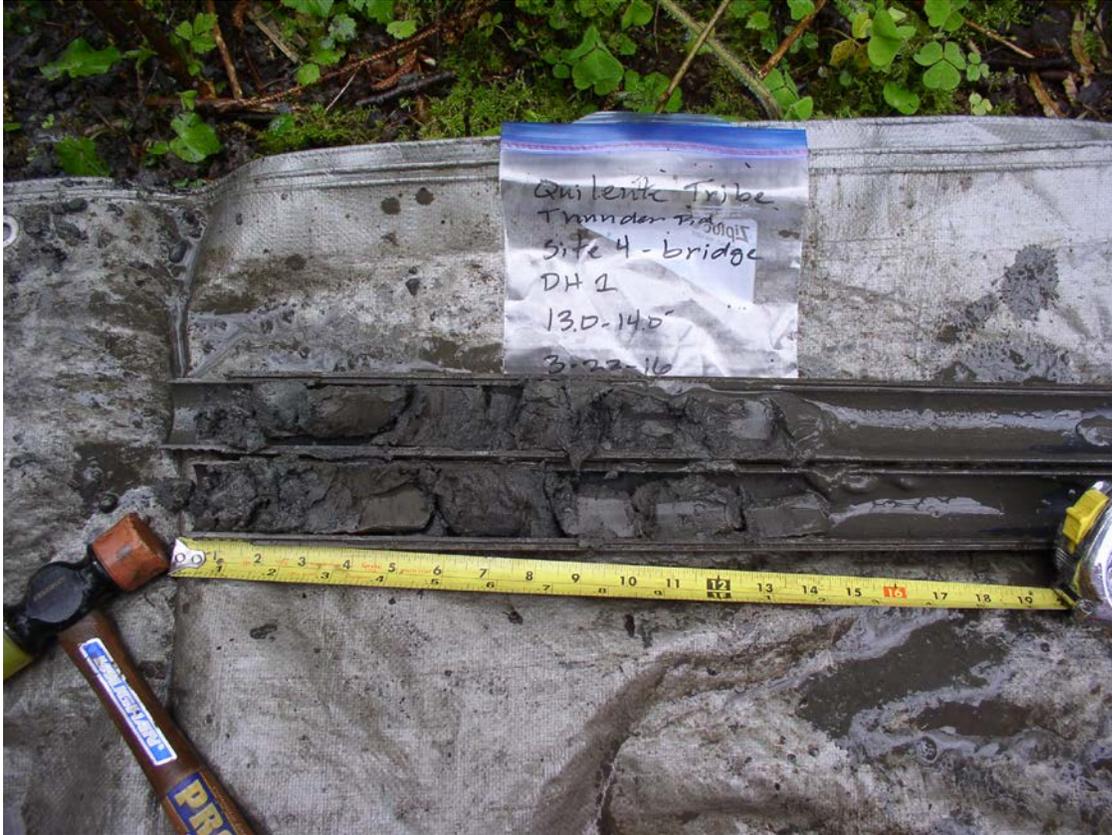
<u>SPT</u>	<u>Number of Blows</u>
12.5 to 13.0 feet	Set
13.0 to 13.5 feet	6
13.5 to 14.0 feet	6
Blows per foot, N =	12

13.0 to 14.0 feet: SM, silty sand with gravel and woody debris, reduced, blue-gray, saturated, medium relative density (Figure 8). Sample collected for laboratory classification.

Figure 8. View of sample recovered from a depth of 13.0 to 14.0 feet.

To reduce the potential for consolidation or bearing failure, consider over excavating to the top of the medium relative density silty sand (SM), and replacing the low density soils with an engineered fill before placing abutments for the new bridge. For design purposes, assume a presumptive bearing capacity of 1.50 tons per square foot for a structure founded on the underlying medium relative density silty sand (SM).
