Quillayute River Project
**Geomorphic Assessment
and Action Plan**

VOLUME II: APPENDICES

**Quillayute River Project
Geomorphic Assessment and Action Plan
Quillayute River Topobathymetric LiDAR Technical Data
Report**

Topobathymetric LiDAR Technical Data Report

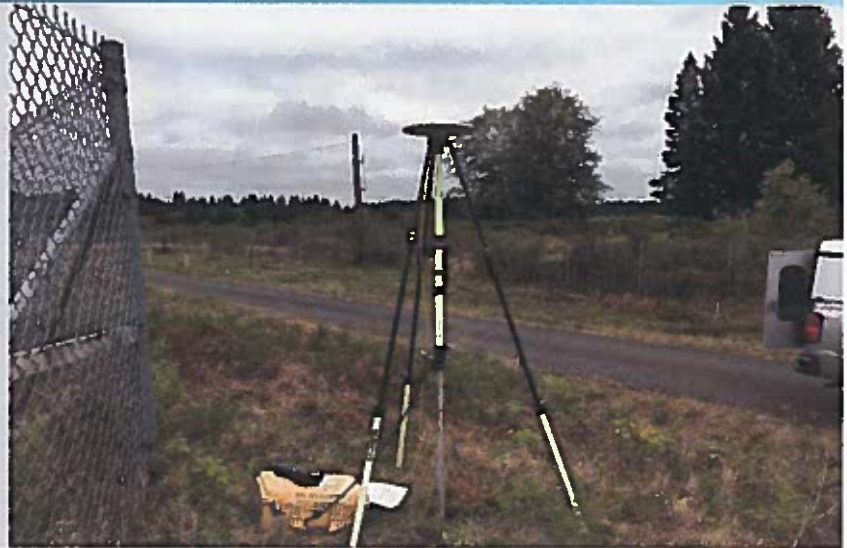
QSI's ground acquisition equipment set up within the Quillayute River LiDAR study area.

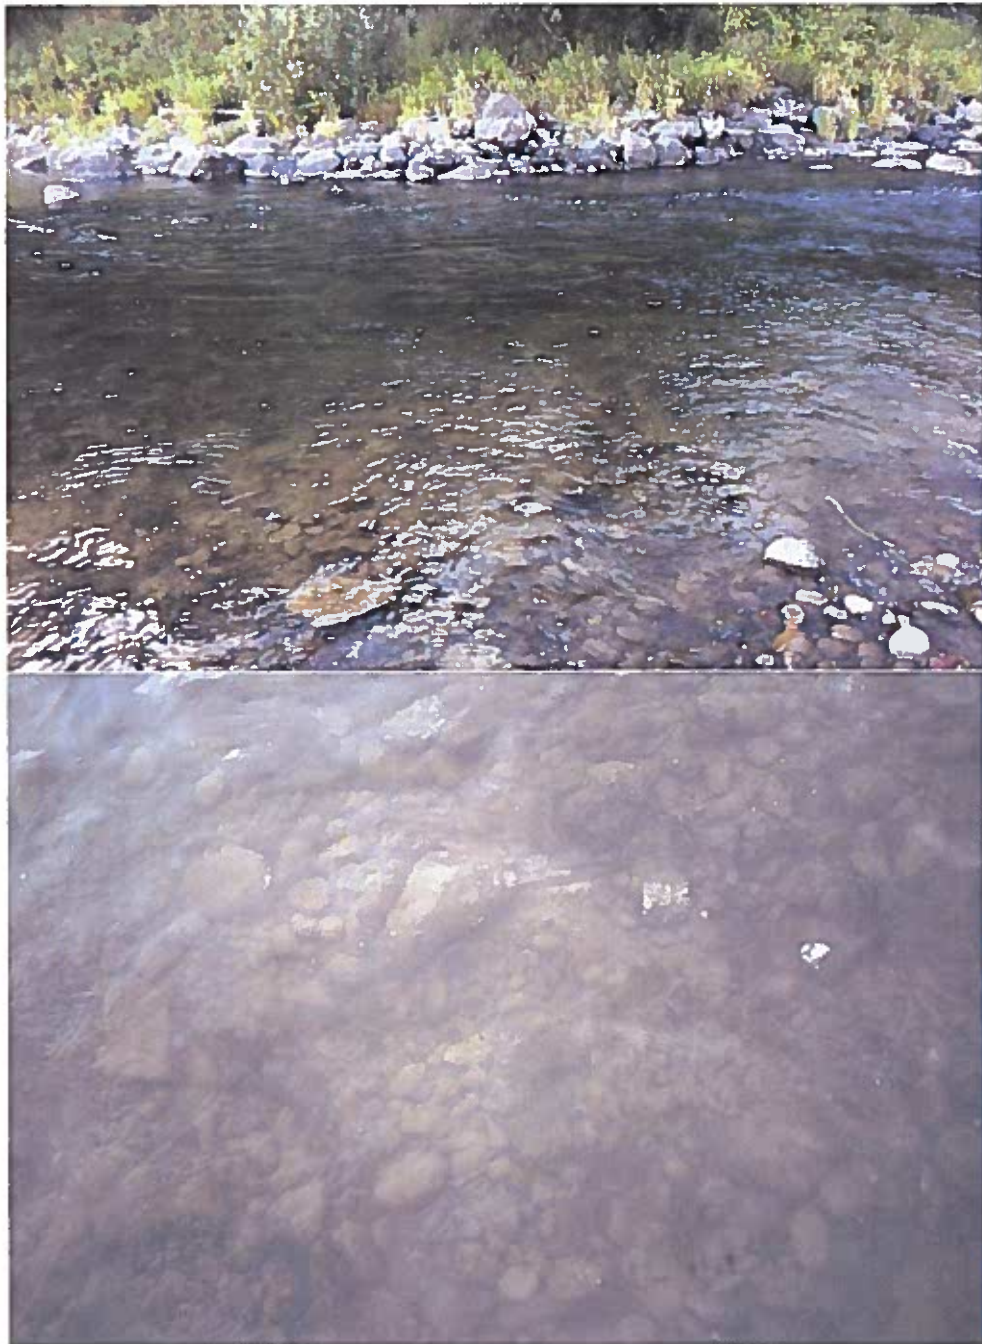
The above images show water clarity conditions at two different sites on the Quillayute River at the time of the LIDAR Acquisition.

In order to assess water clarity conditions prior to and during LiDAR and digital imagery collection, QSI collected turbidity measurements prior to airborne acquisition. Readings were collected at six locations throughout the project site between August 28 and August 30, 2019. The table below provides turbidity results per site on each day of data collection.

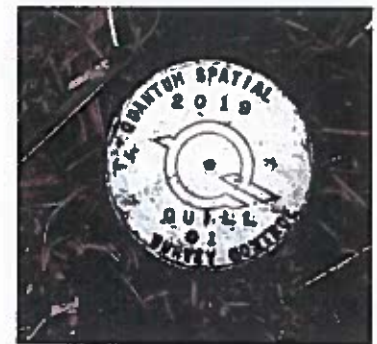
QSI Established Monument

Monument locations were selected with consideration for satellite visibility, field crew safety, and optimal location for GSP coverage. QSI established one new monument for the Quillayute River LiDAR project (Table 5, Figure 6). New monumentation was set using 5/8" x 30" rebar topped with stamped 2 ½" aluminum caps. QSI's professional land surveyor, Evon Silvia (WAPLS#53957) oversaw and certified the ground survey.

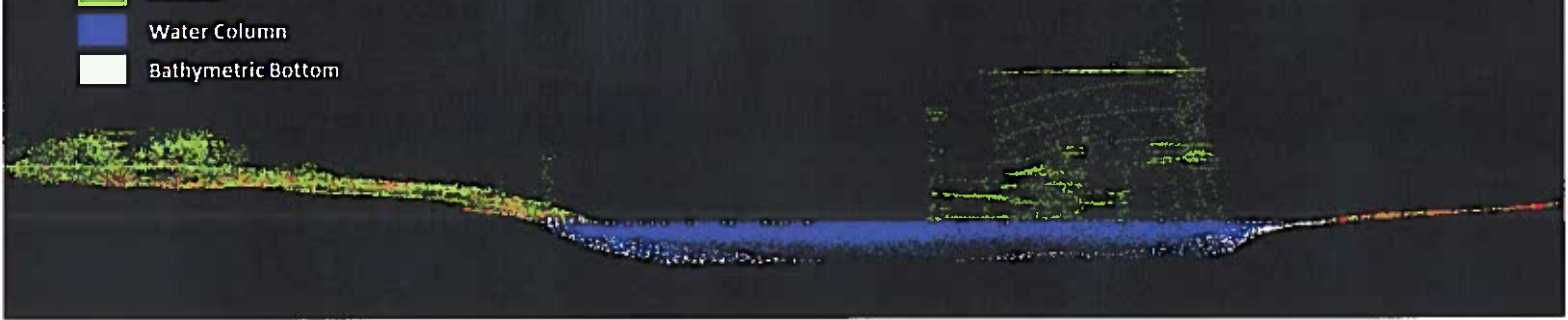
- Ground
- Default
- Water Column
- Bathymetric Bottom

This 2 meter wide cross section shows a view of the mouth of the Quillayute River colored by laser point classification.

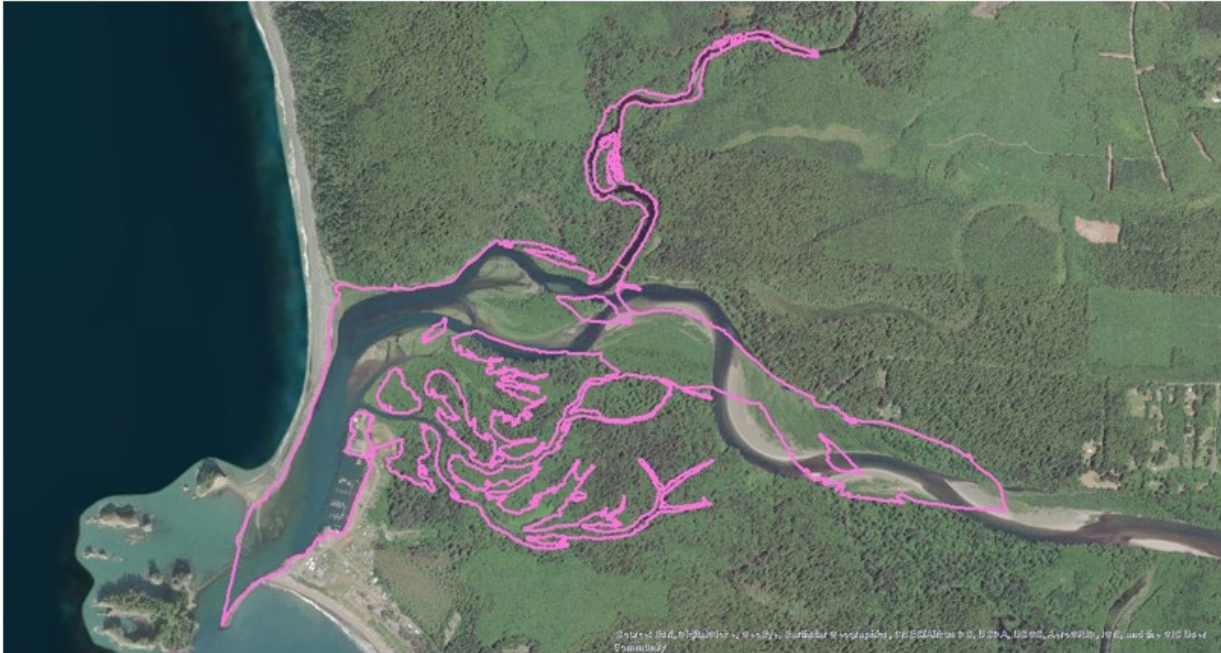
Figure 2-6. Present and Historic Tidal Estuary Extents

The Pacific Marine and Estuarine Fish Habitat Partnership (PMEP) has developed GIS mapping of current and historical extents of tidal wetlands the Quillayute River estuary. Figure 2-6 shows the tidal wetland limits. The mapping includes areas currently inundated by the tides (“current tidal wetlands”) from the ocean to the head of tide, including the freshwater tidal zone. To assist restoration planning, the mapping also includes areas that were historically inundated by the dikes and tide gates (“historical tidal wetlands”). Although the mapping does not yet distinguish current from historical (disconnected) tidal wetlands, a future mapping phase will provide this information (PMEP 2019).

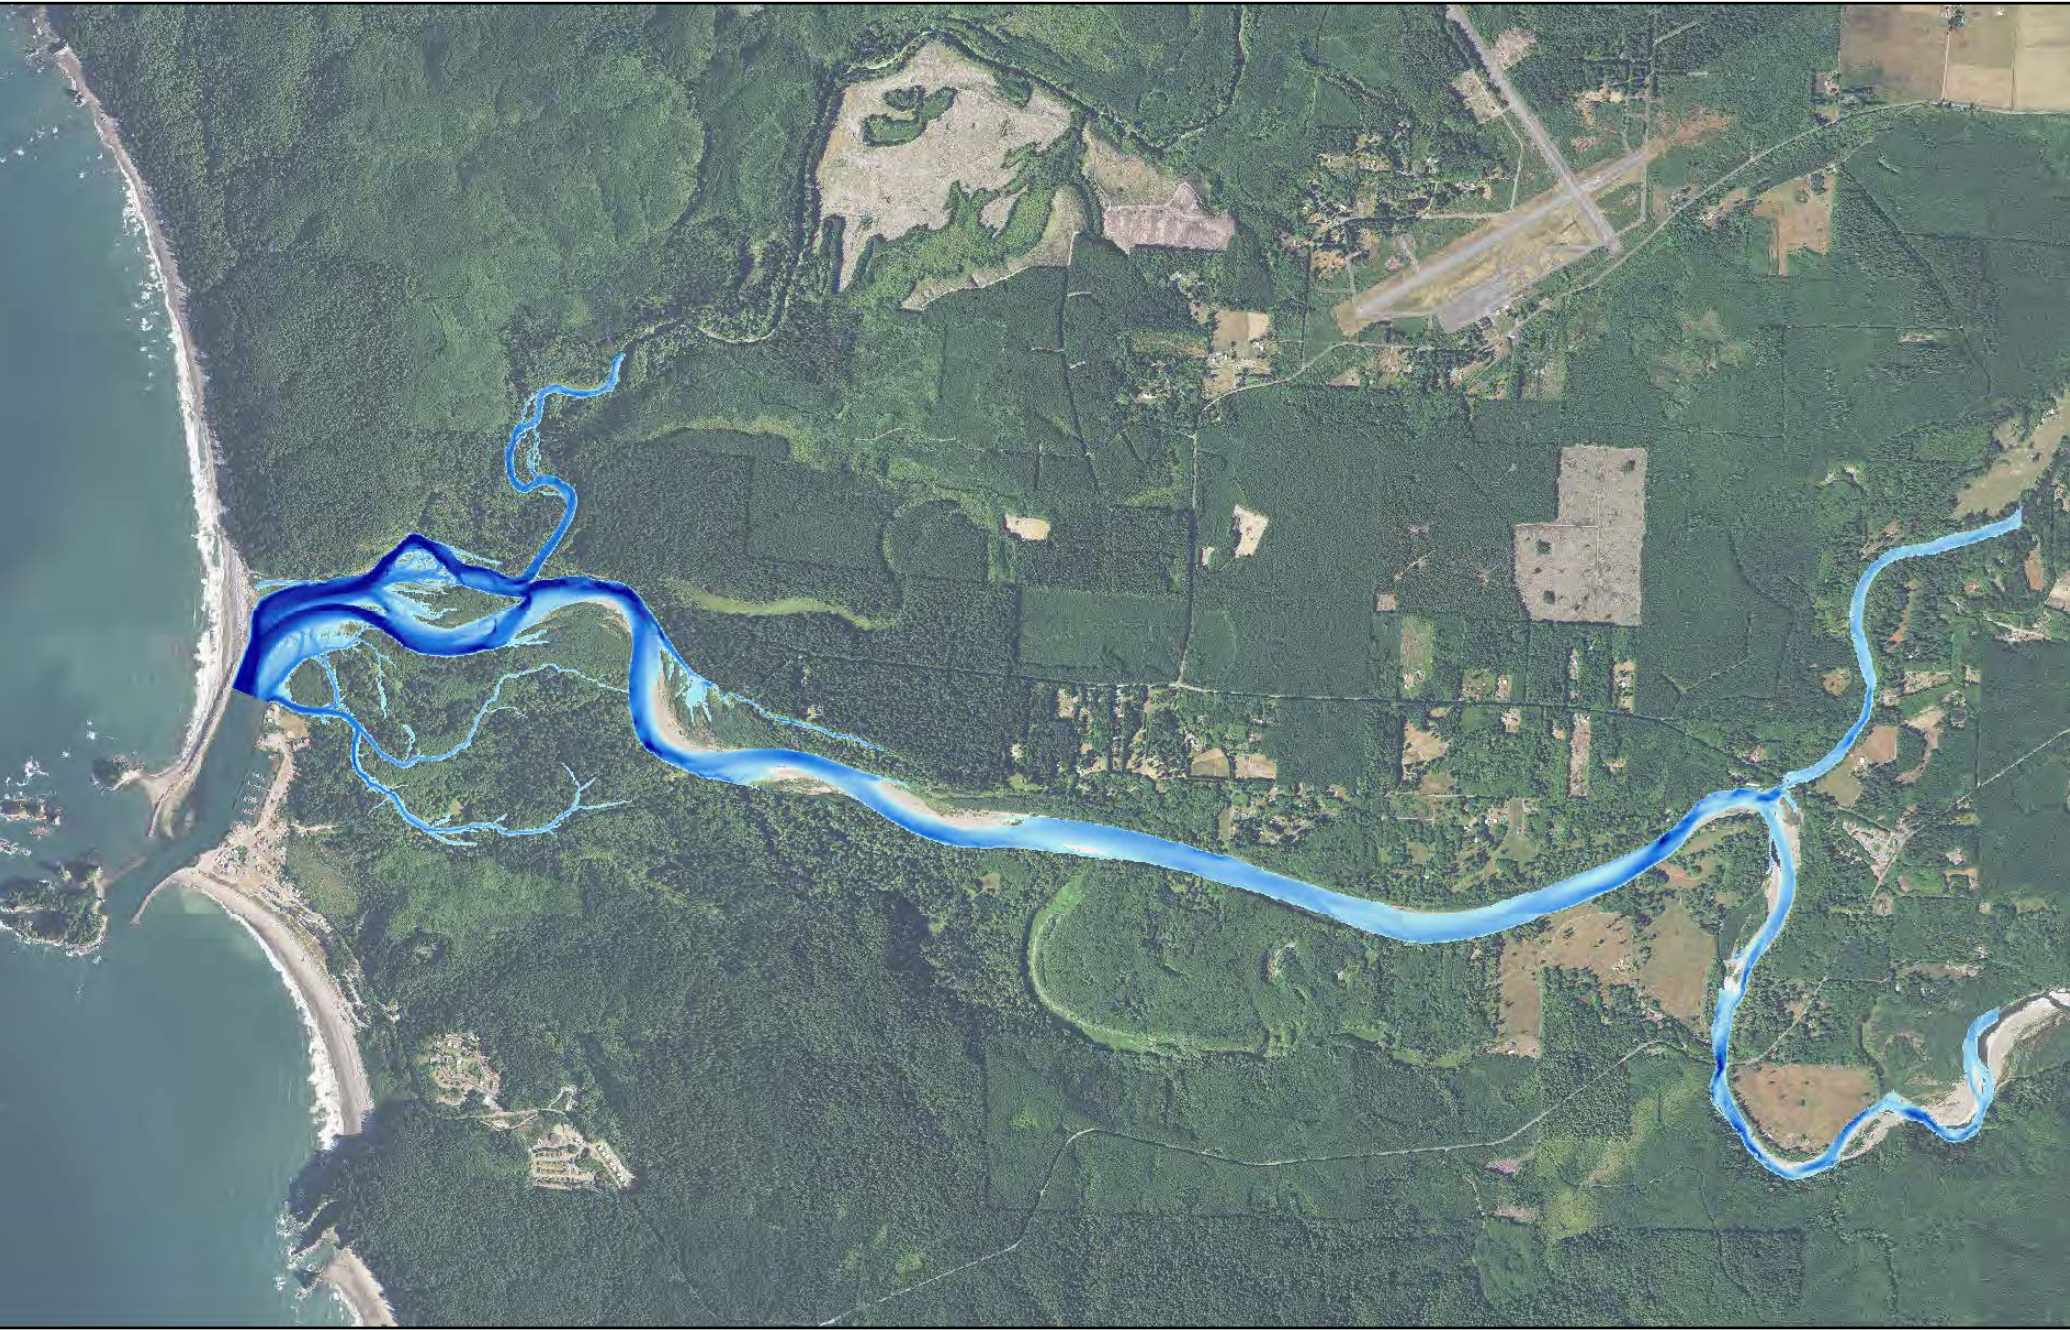
Habitat Suitability Modeling
 Depth
 High Flow/High Tide
 Figure I-1

Quillayute River Flow: 2,890 cfs
 High Tide: 7.85 ft. (NAVD88)
 Low Tide: -0.66 ft. (NAVD88)

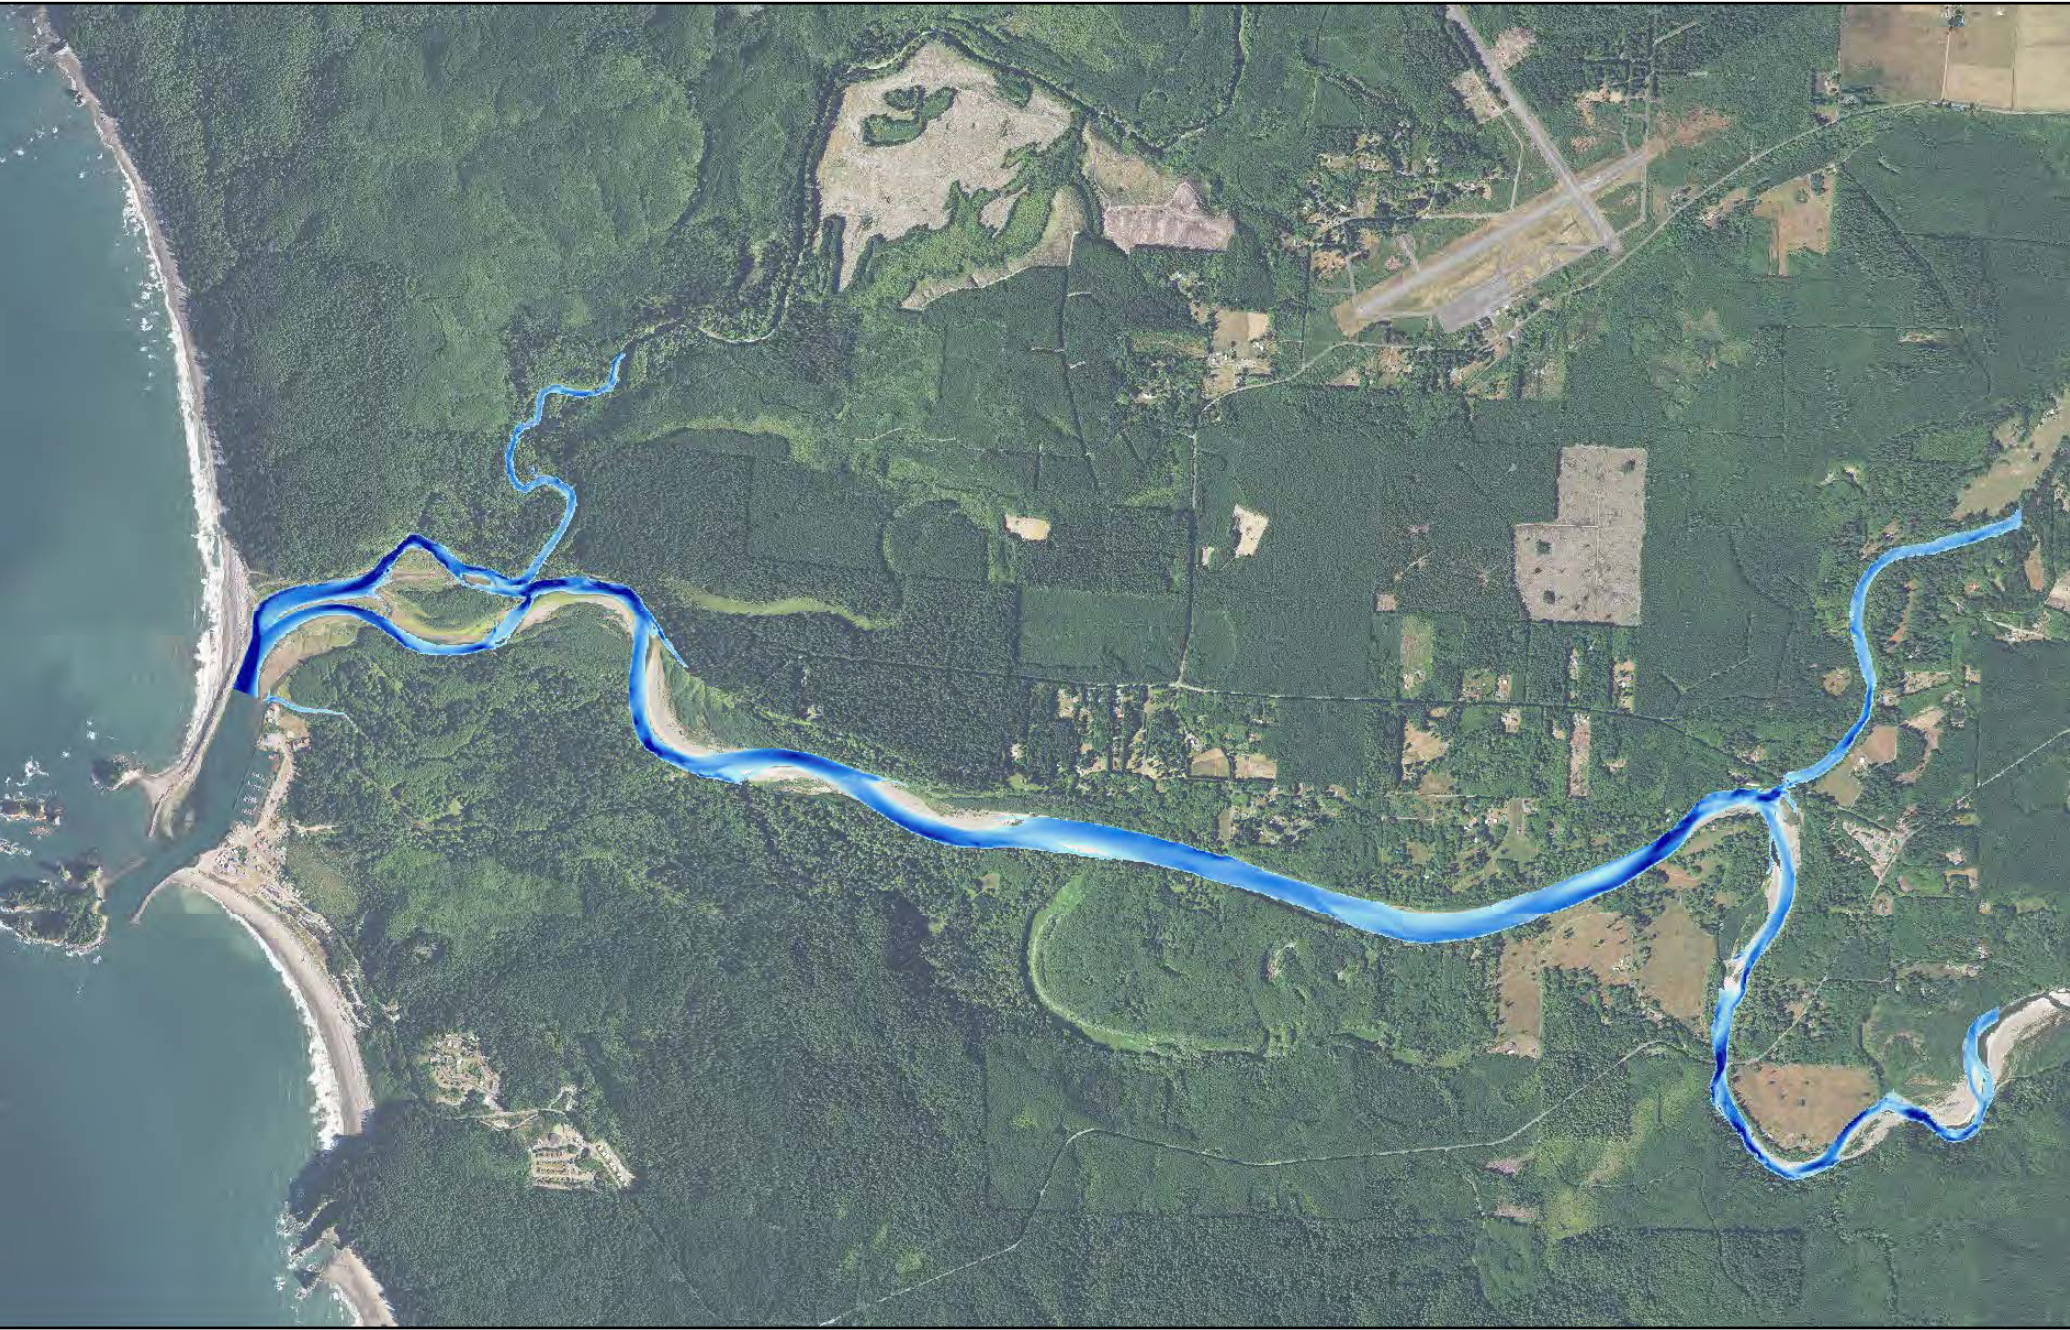
Habitat Suitability Modeling
Depth
High Flow/Low Tide
Figure I-2

Quillayute River Flow: 2,890 cfs
High Tide: 7.85 ft. (NAVD88)
Low Tide: -0.66 ft. (NAVD88)

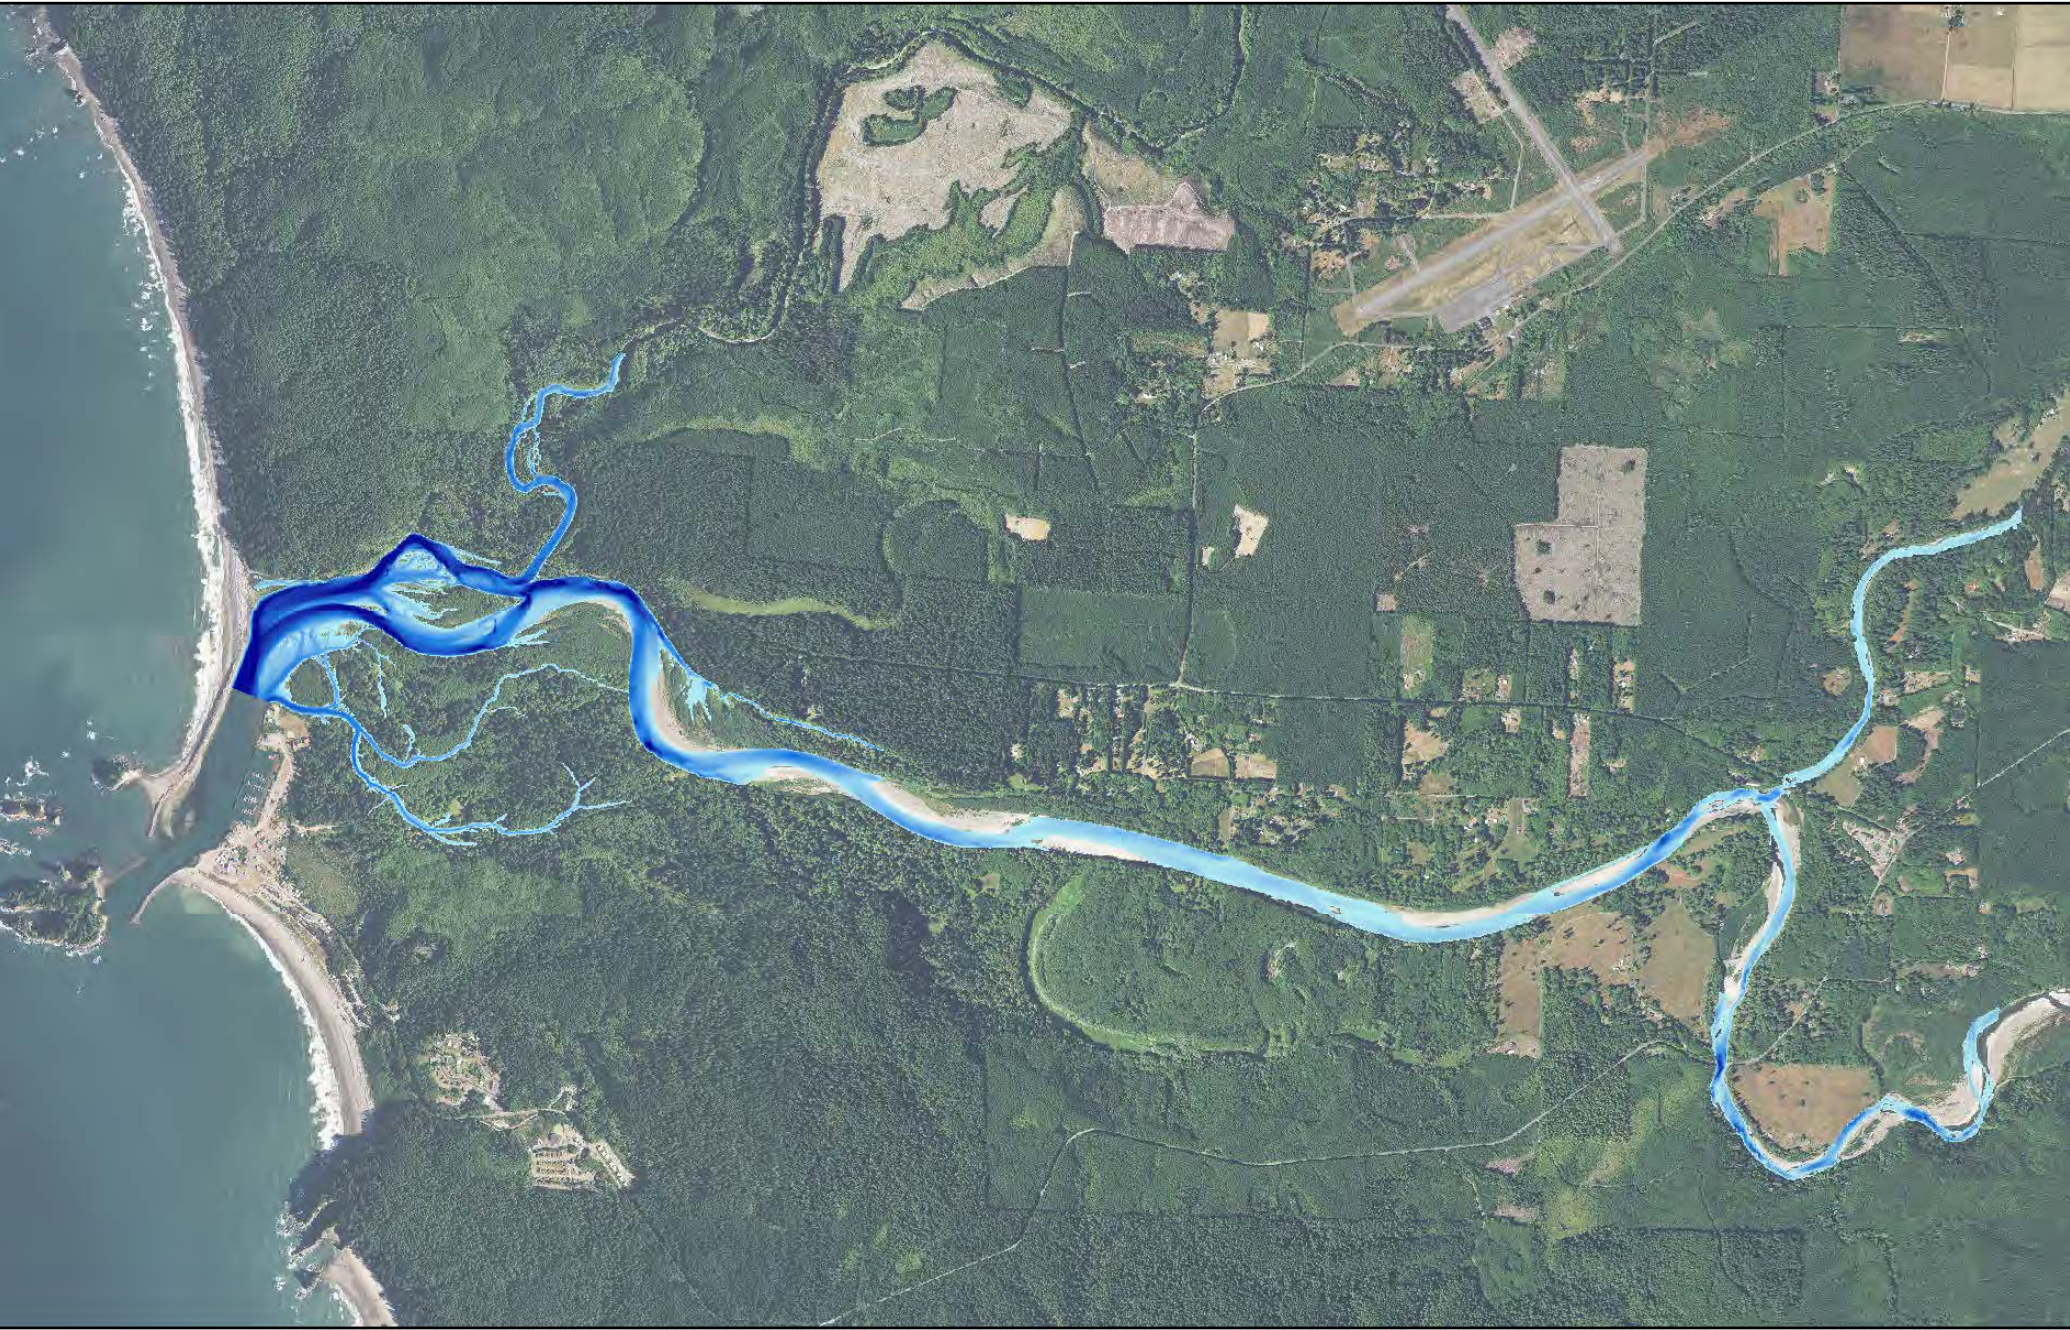
Habitat Suitability Modeling
Depth
Low Flow/High Tide
Figure I-3

Quillayute River Flow: 423 cfs
High Tide: 7.85 ft. (NAVD88)
Low Tide: -0.66 ft. (NAVD88)

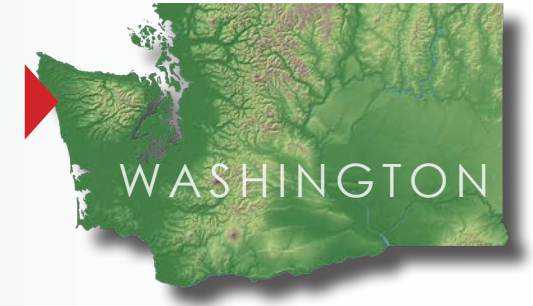
ALTERNATIVE 1

- Lowered Jetty for High Flow and Tide Flood Relief
- Remove Culvert to Create Backwater Alcove
- New Berm/Levee
- Decompact Surface
- High Flow Channel with Helicopter Log Placement
- Backwater Alcove
- Wetland
- Helicopter Log Placement
- Log Jam
- Improved Fishing Access
- Thunder Field Road Improvement
- Mora Road Relocation
- Mora Road Connection Options
- Lay Back Banks and Install Fish-friendly Large Wood Structures
- Install Fish-friendly Bank Protection via Bioengineering with Log Jams
- Walking Path

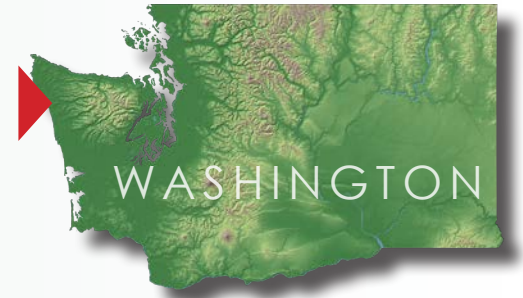
ALTERNATIVE 2

- Improve Existing Berm
- Replace Culvert with Fish-friendly Structures to Reconnect Habitat
- Decompact Surface
- High Flow Channel with Large Wood Structures
- Backwater Alcove
- Large Wood Structure
- Log Jam
- Improved Fishing Access
- Thunder Field Road Improvement
- Log Revetment
- Lay Back Banks and Install Fish-friendly Large Wood Structures

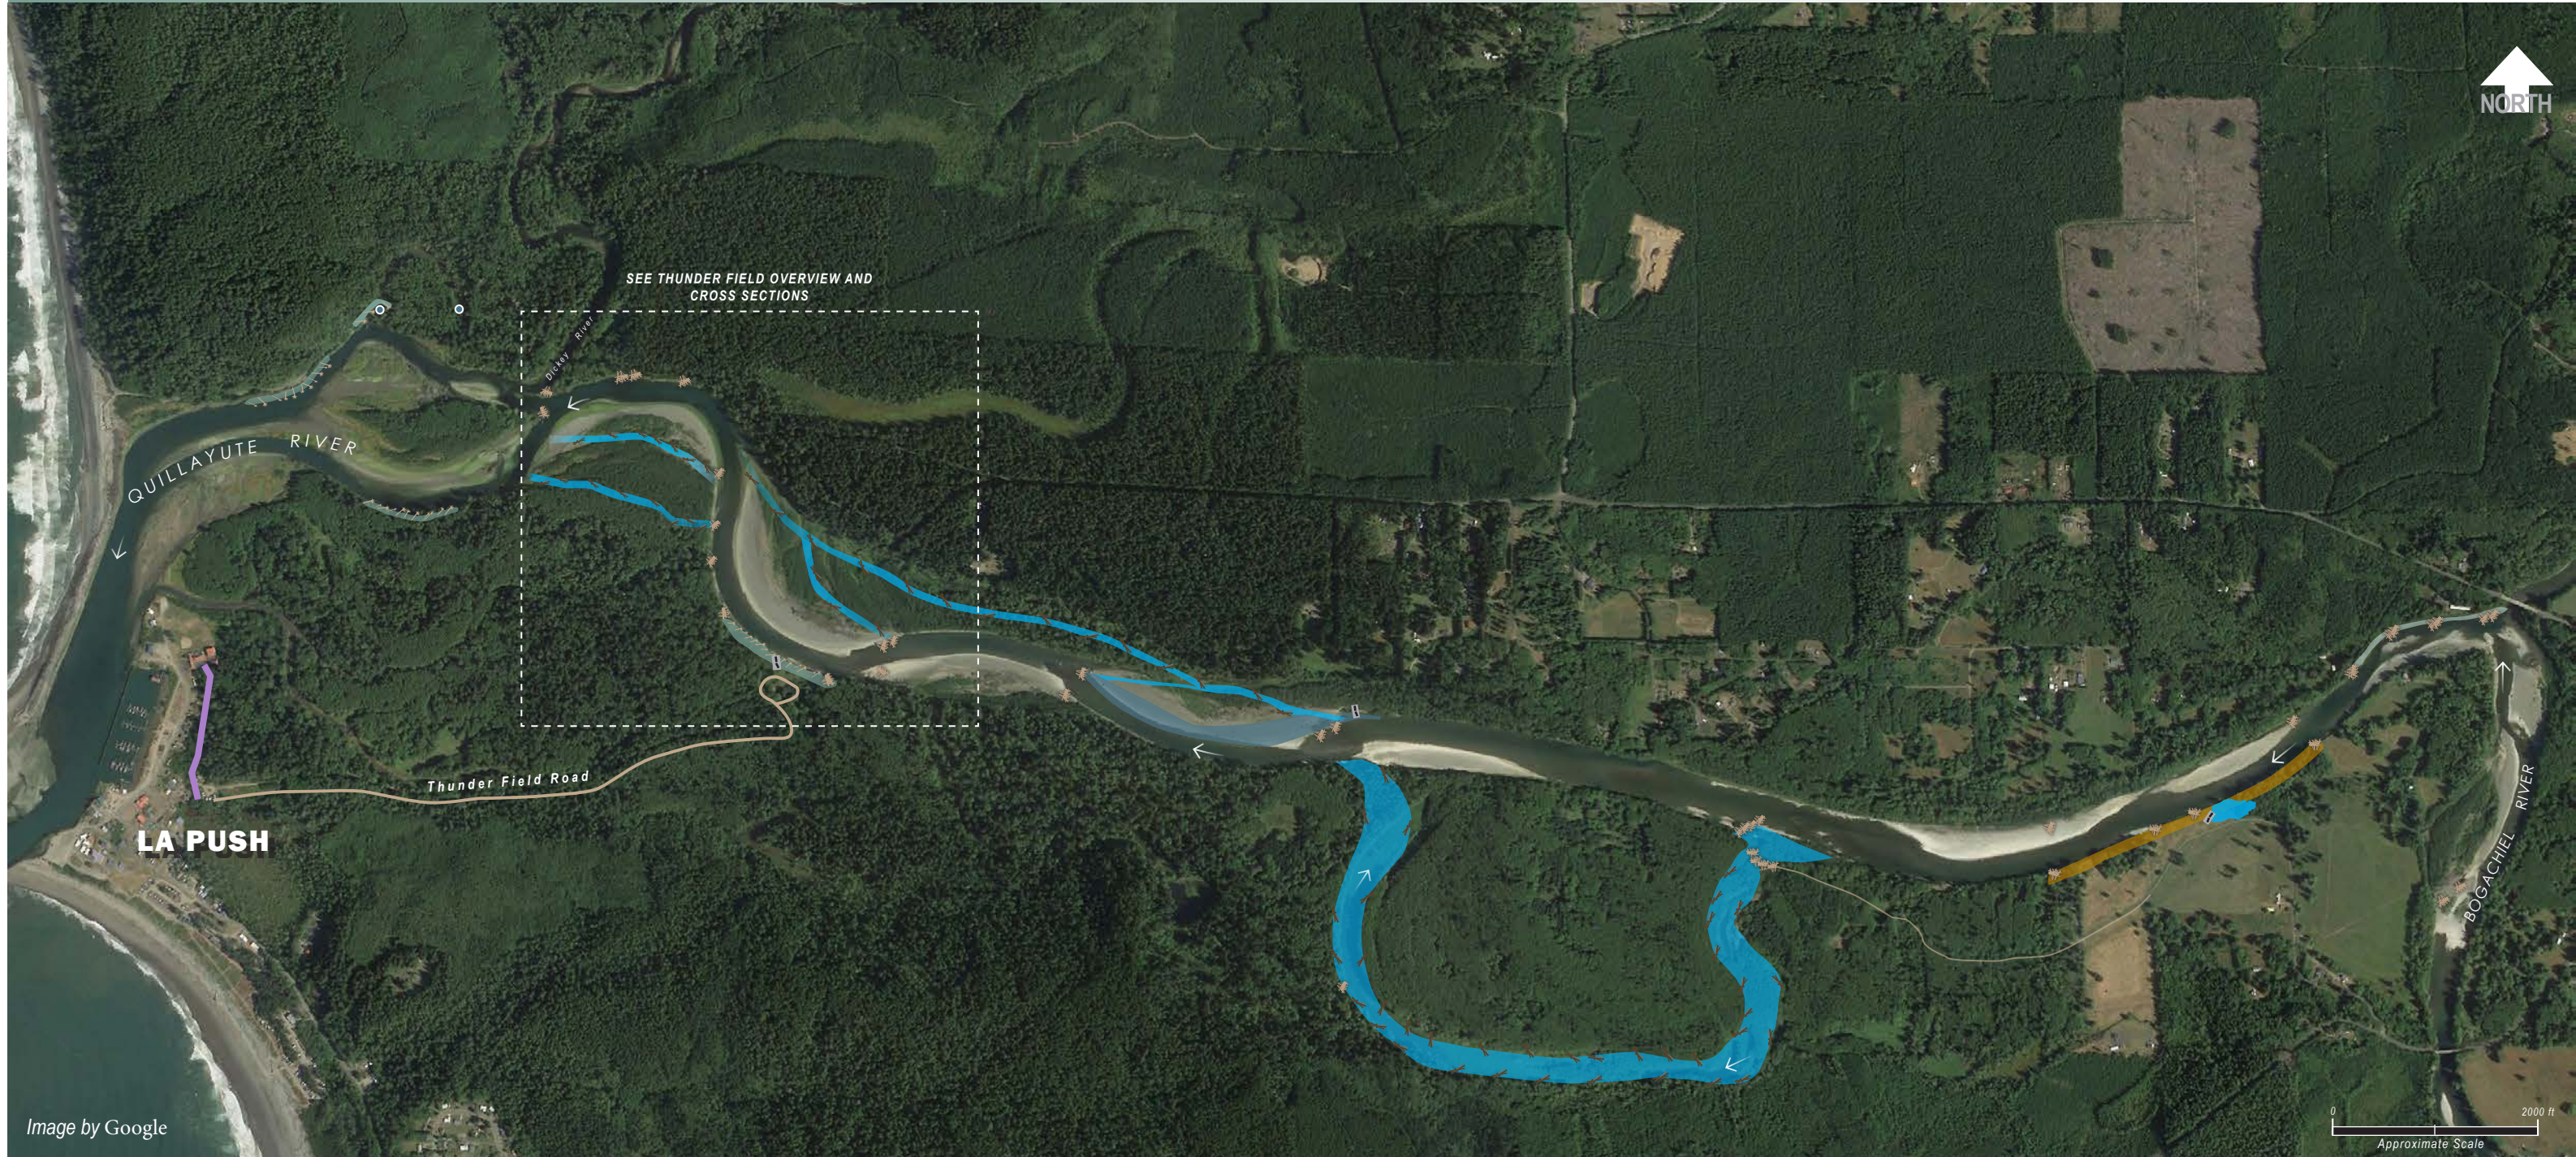
ALTERNATIVE 2: THUNDER FIELD OVERVIEW AND CROSS SECTIONS

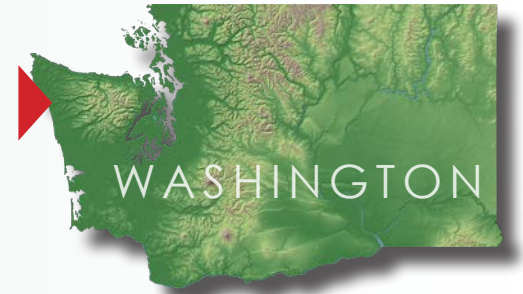
ALTERNATIVE 3

- New Levee
- Replace Culvert with Fish-friendly Structures to Reconnect Habitat
- Launchable Rock
- Improved Fishing Access
- Thunder Field Road Improvement
- Log Revetment

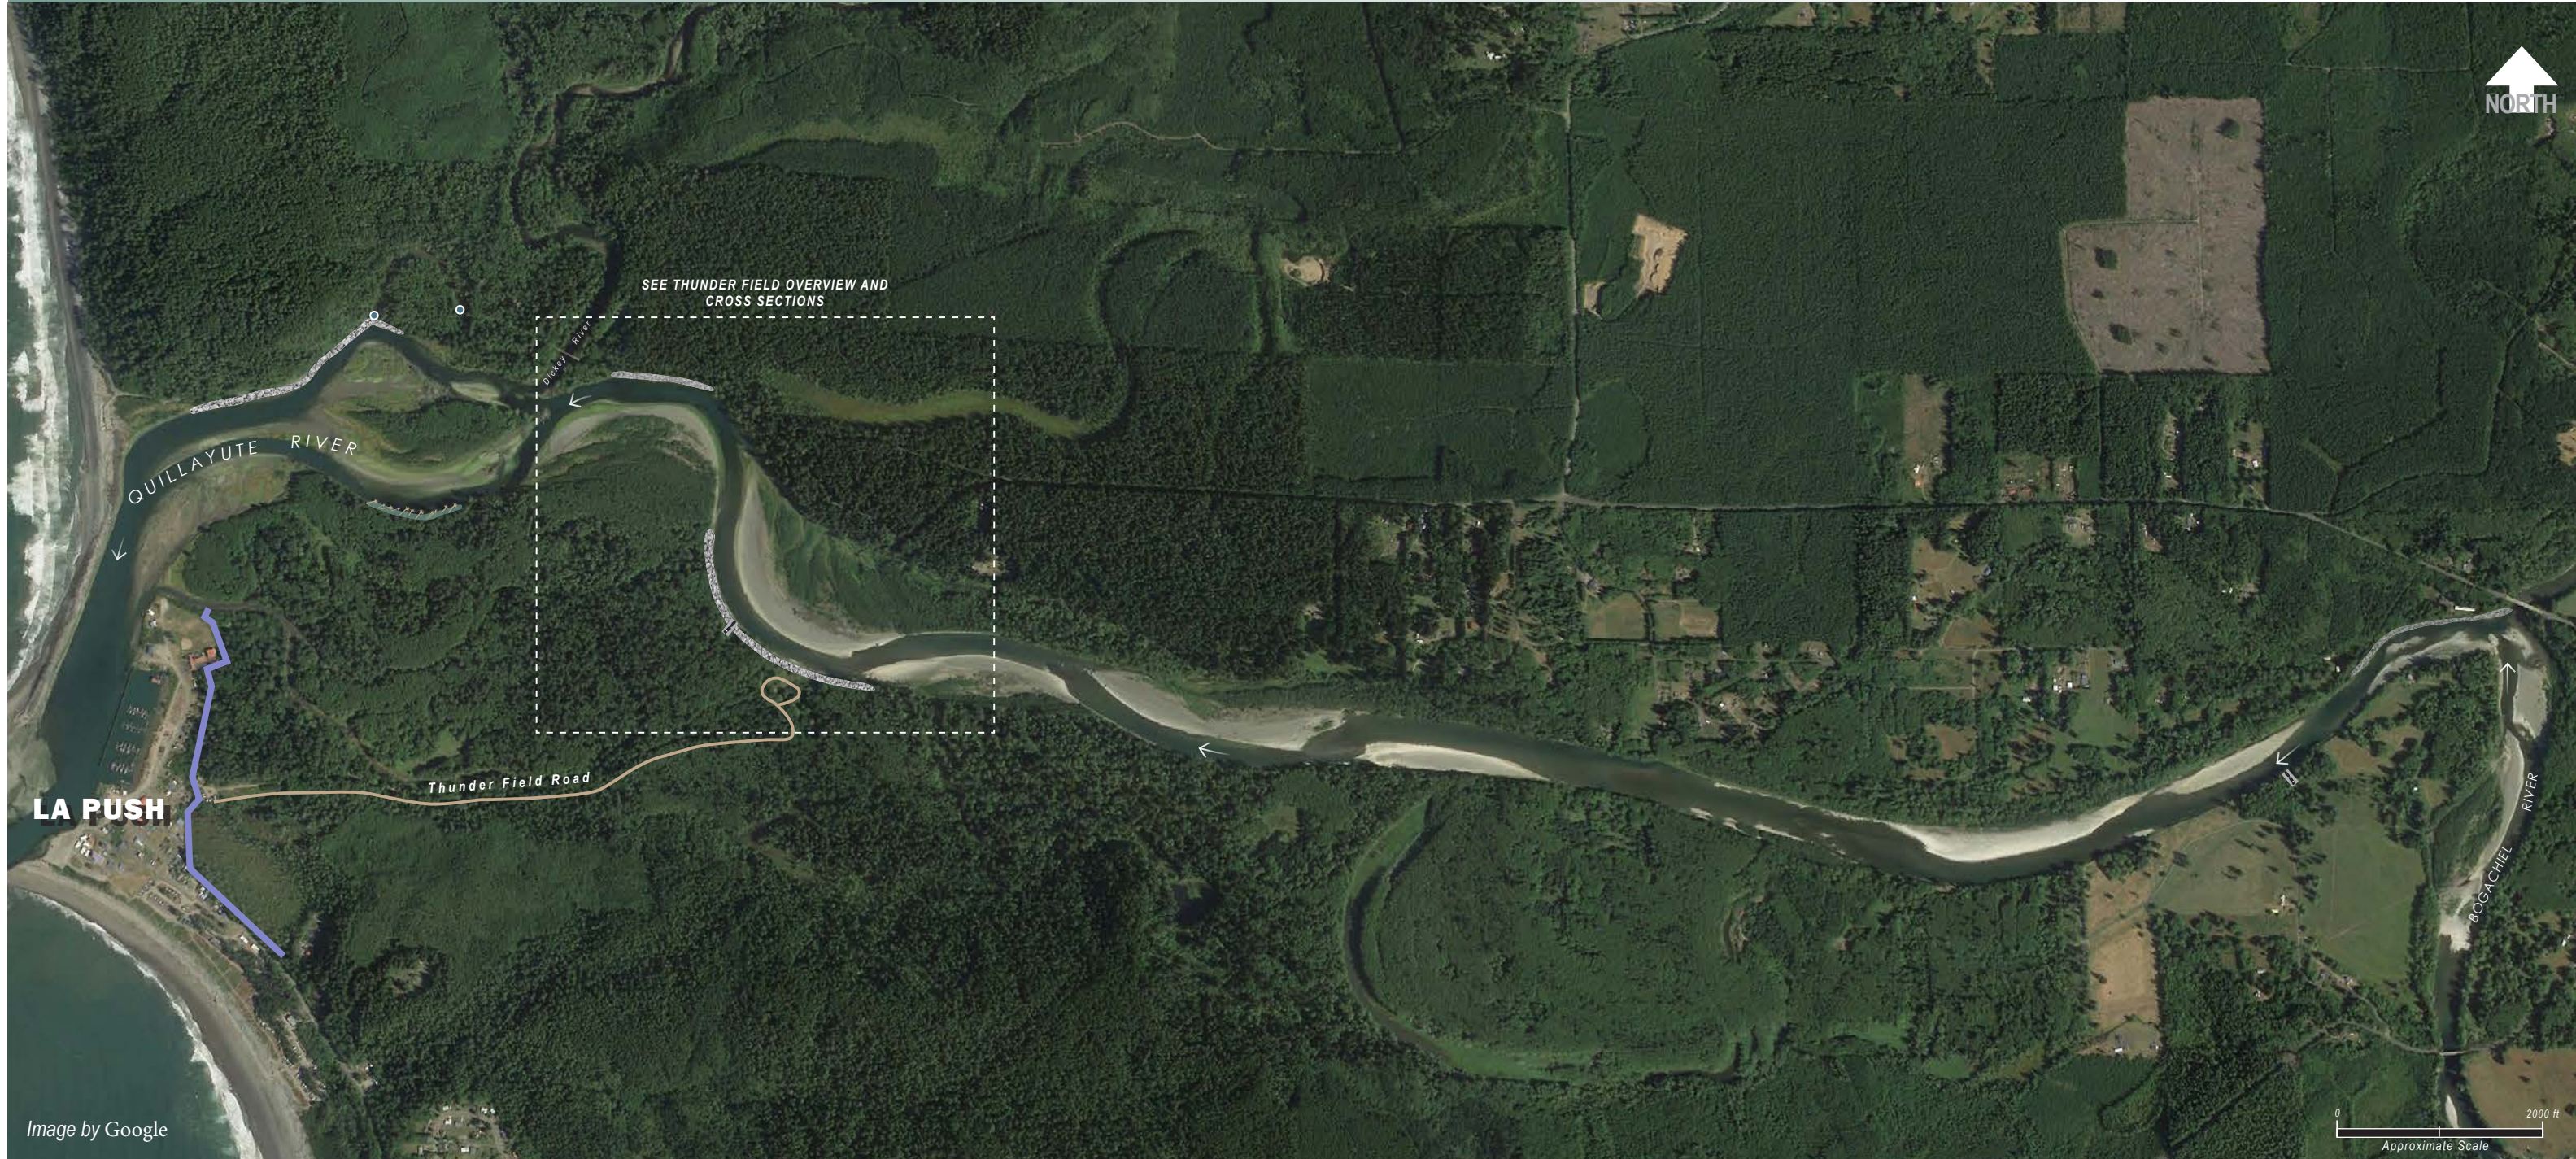
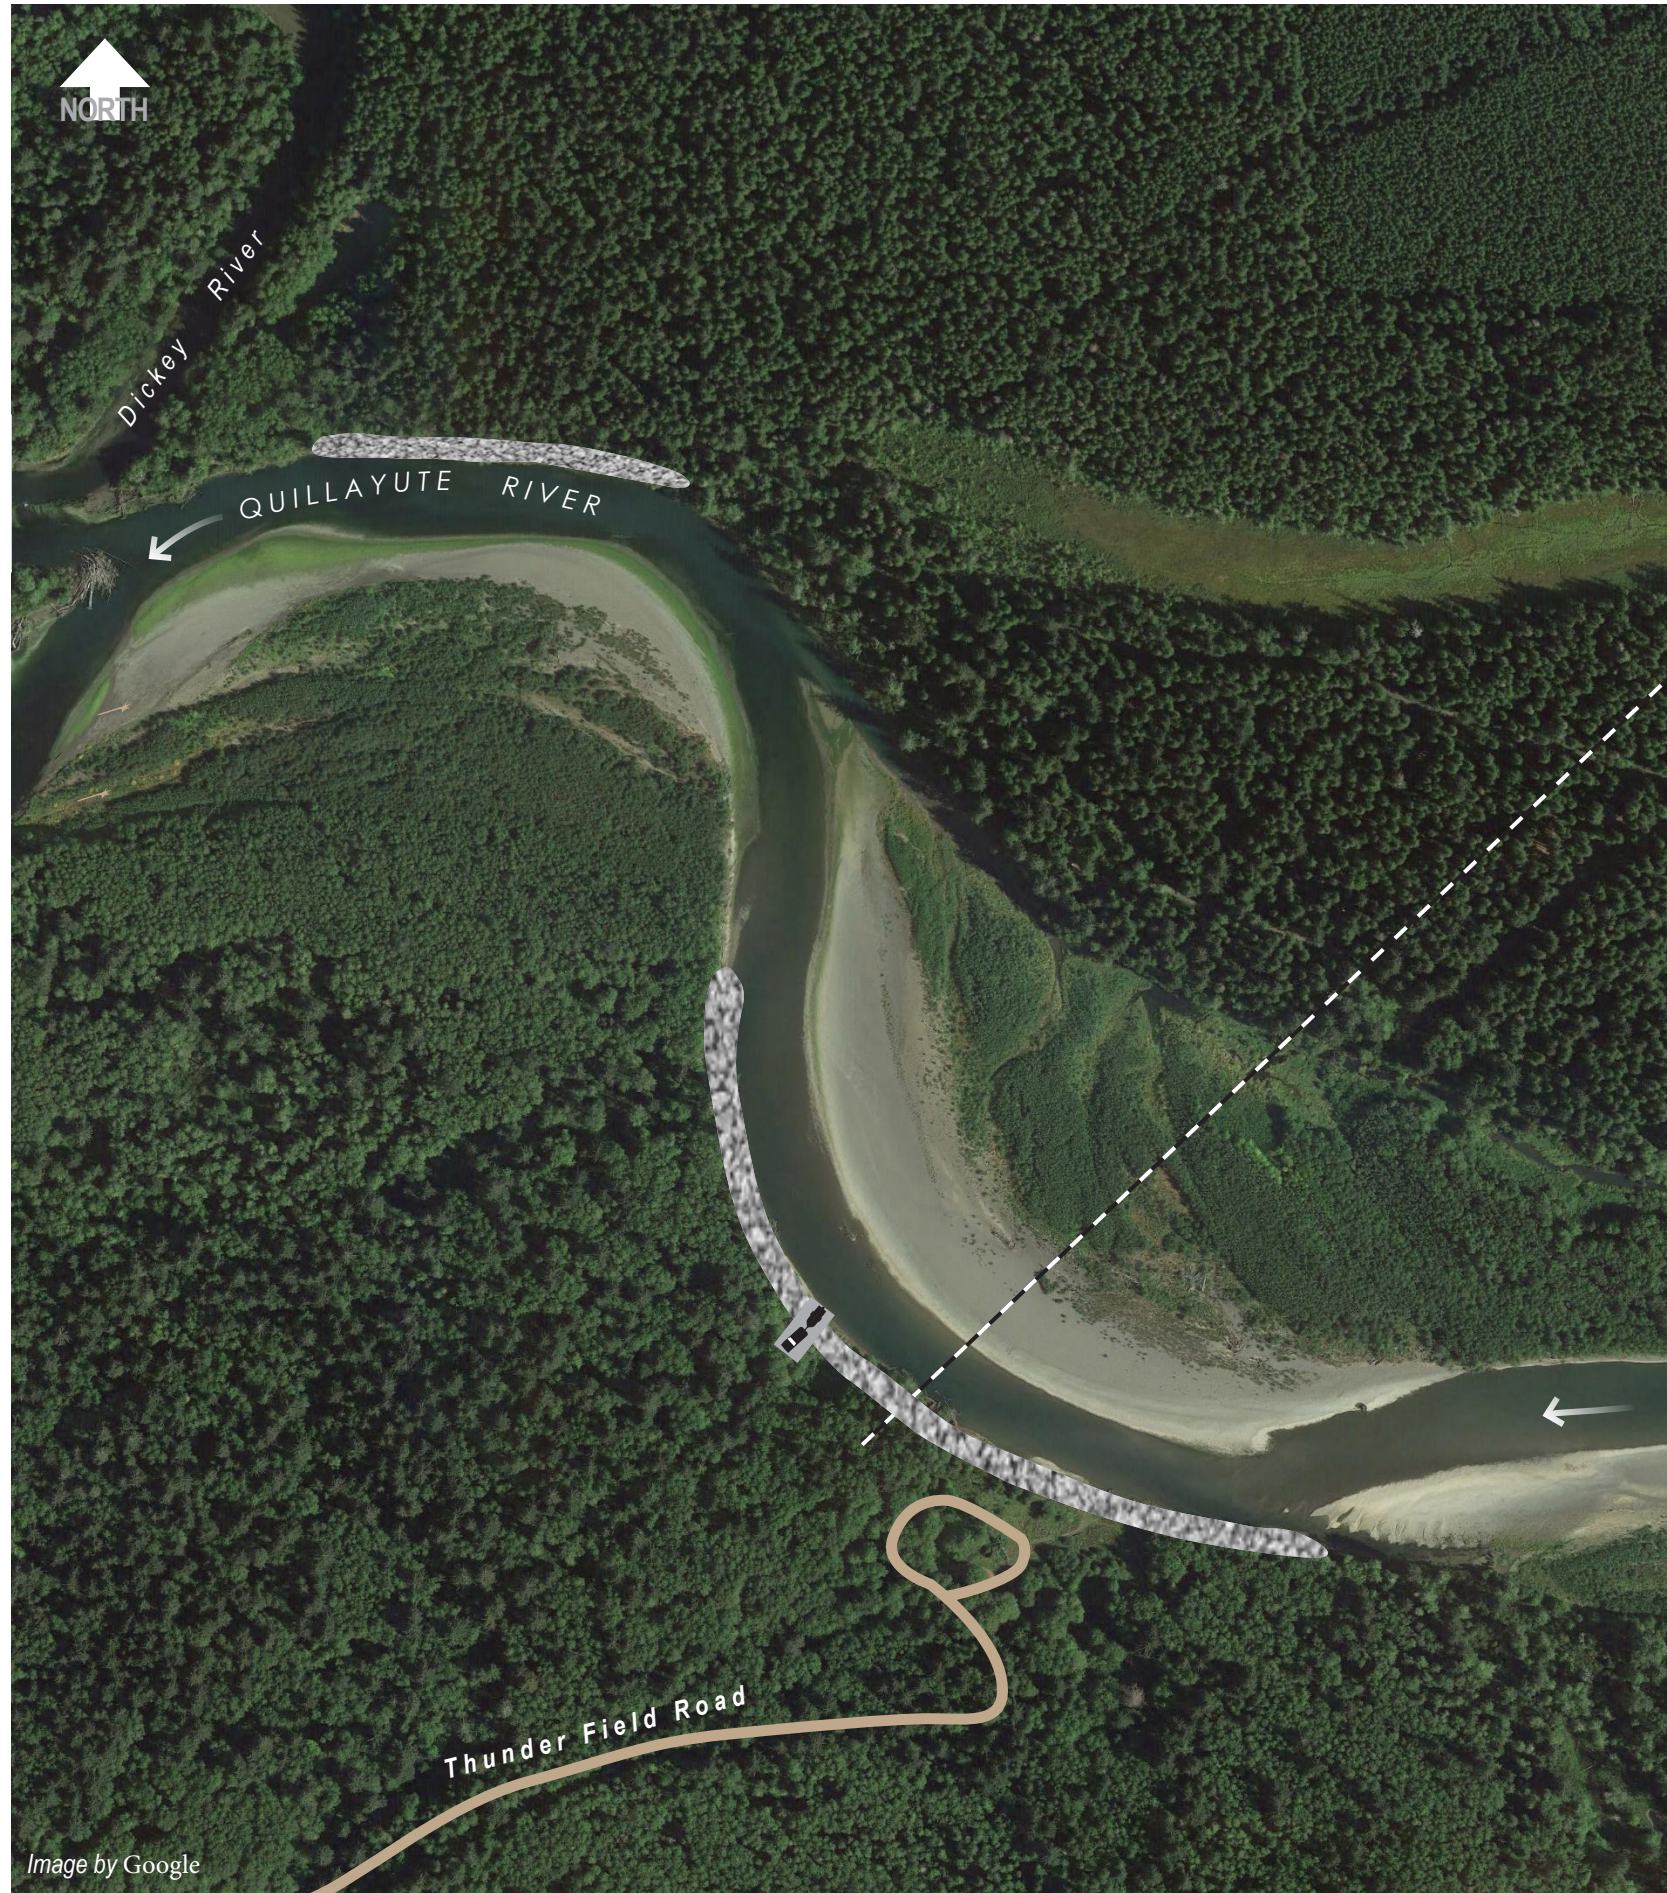
ALTERNATIVE 3: THUNDER FIELD OVERVIEW AND CROSS SECTIONS
