Quillayute River Project
**Geomorphic Assessment
and Action Plan**

VOLUME II: APPENDICES

**Quillayute River Project
Geomorphic Assessment and Action Plan
Quillayute River Topobathymetric LiDAR Technical Data
Report**

Topobathymetric LiDAR Technical Data Report

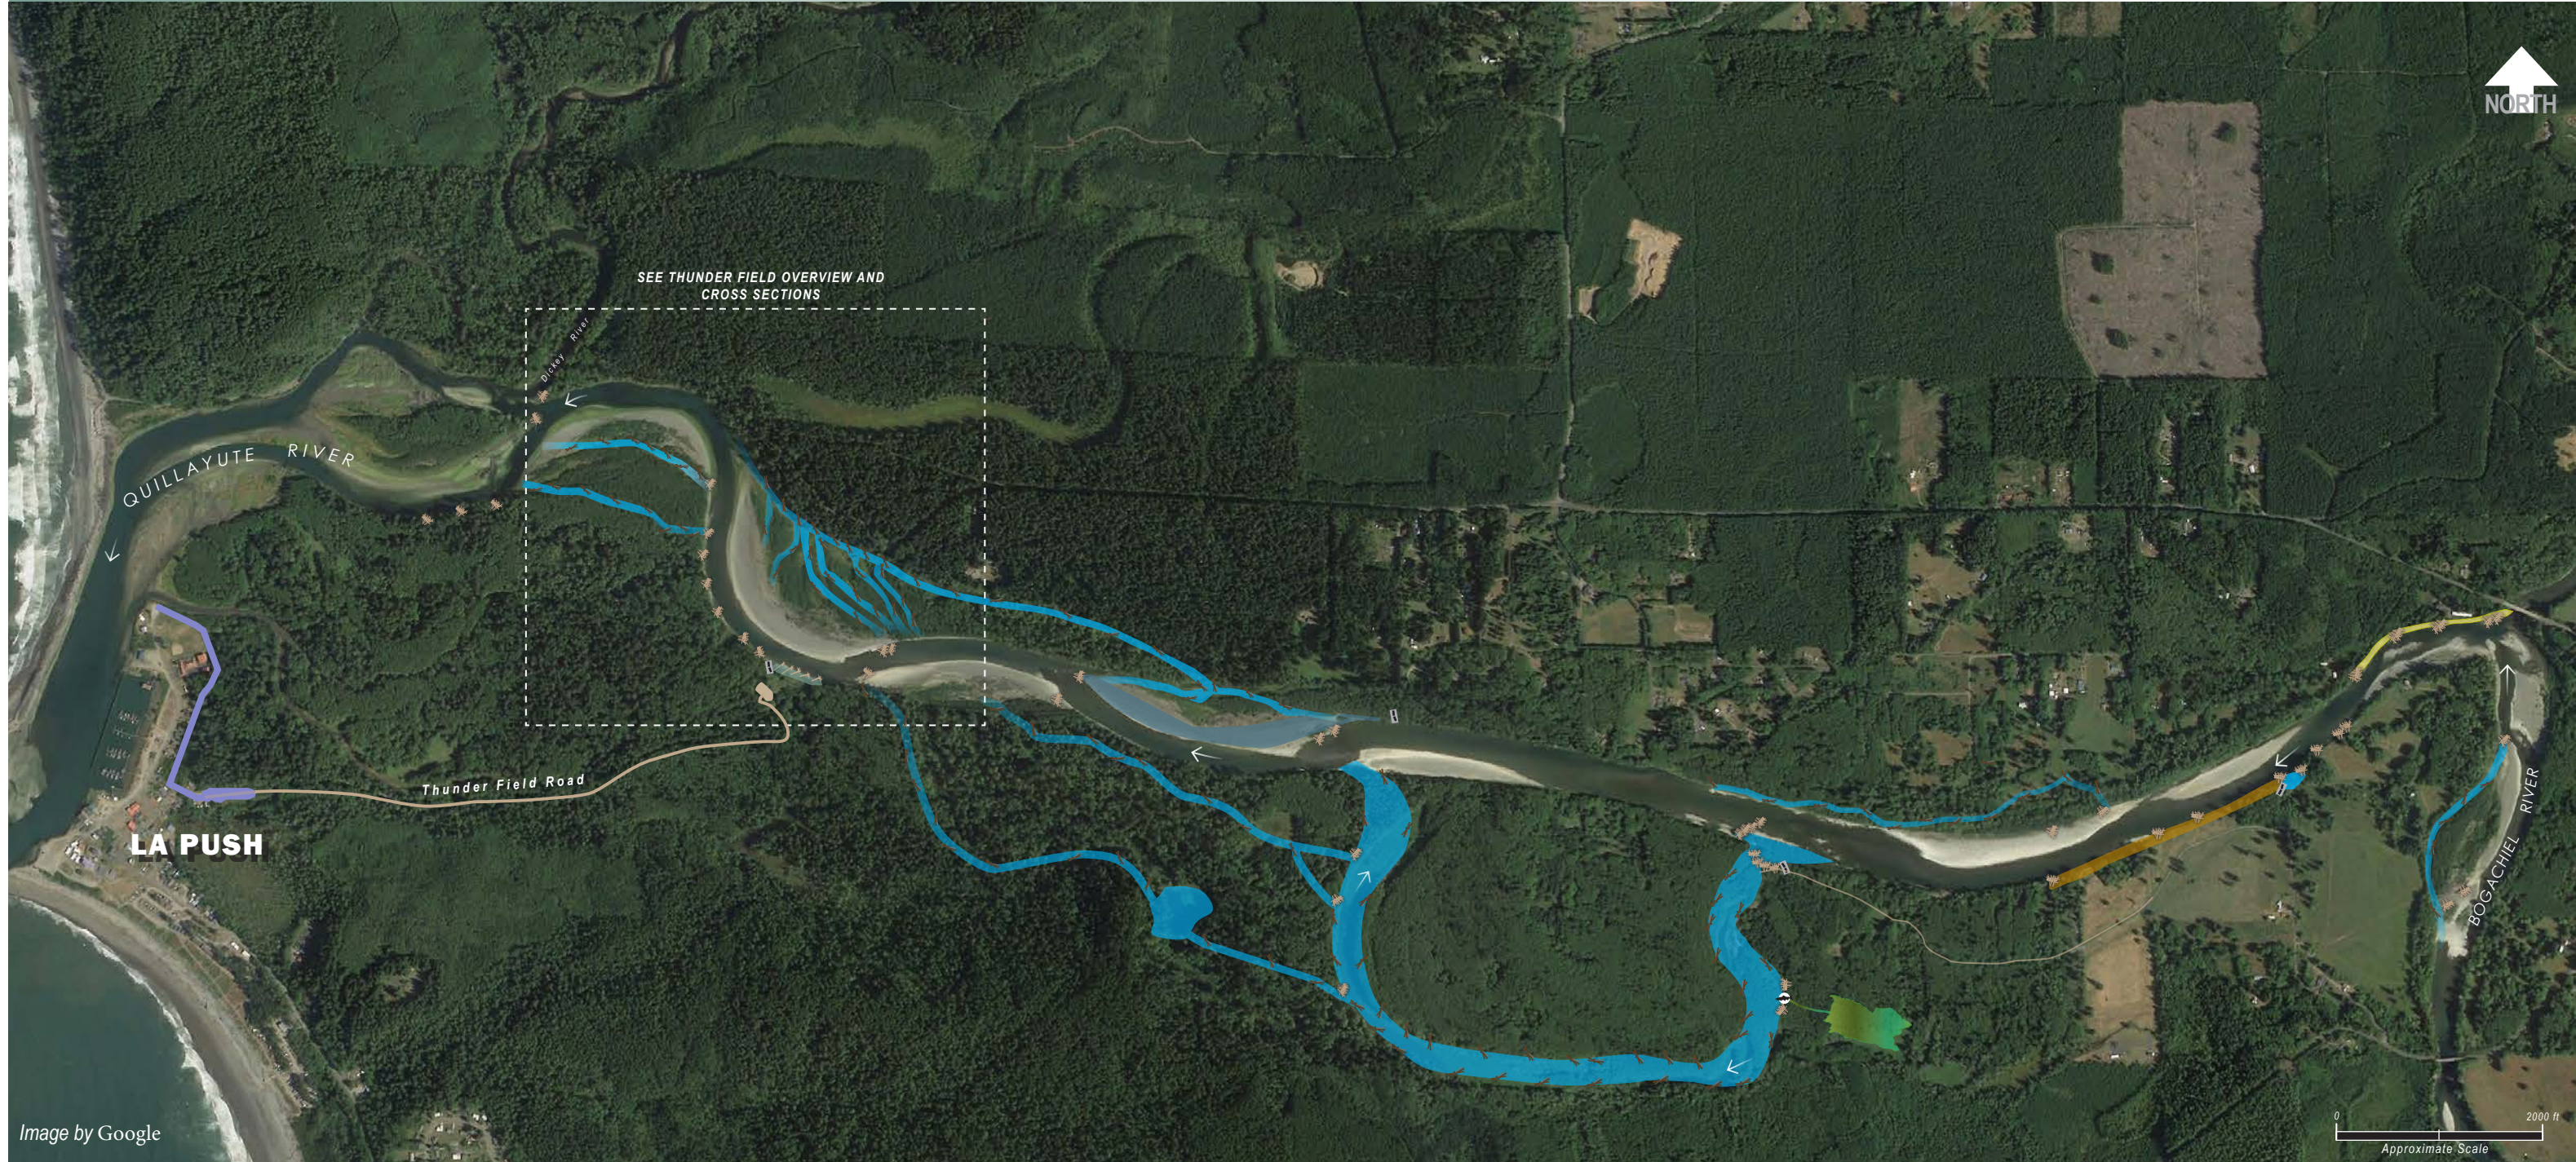
Figure K-9

- Install Fish-friendly Structure
- Improved Berm/Levee
- Decompact Surface
- High Flow Channel with Large Wood Structures
- Backwater Alcove
- Wetland
- Large Wood Structure
- Log Jam
- Improved Fishing Access
- Thunder Field Road Improvement
- Lay Back Banks and Install Fish-friendly Large Wood Structures
- Install Fish-friendly Bank Protection via Bioengineering with Log Jams
- Log Revetment

ALTERNATIVE 1B: THUNDER FIELD OVERVIEW AND CROSS SECTIONS
